PREPARATION AND OPERATIONS OF THE MISSION PERFORMANCE  
CENTRE (MPC) FOR THE COPERNICUS SENTINEL-3 MISSION

**S3-A SLSTR Cyclic Performance Report**

**Cycle No. 016**

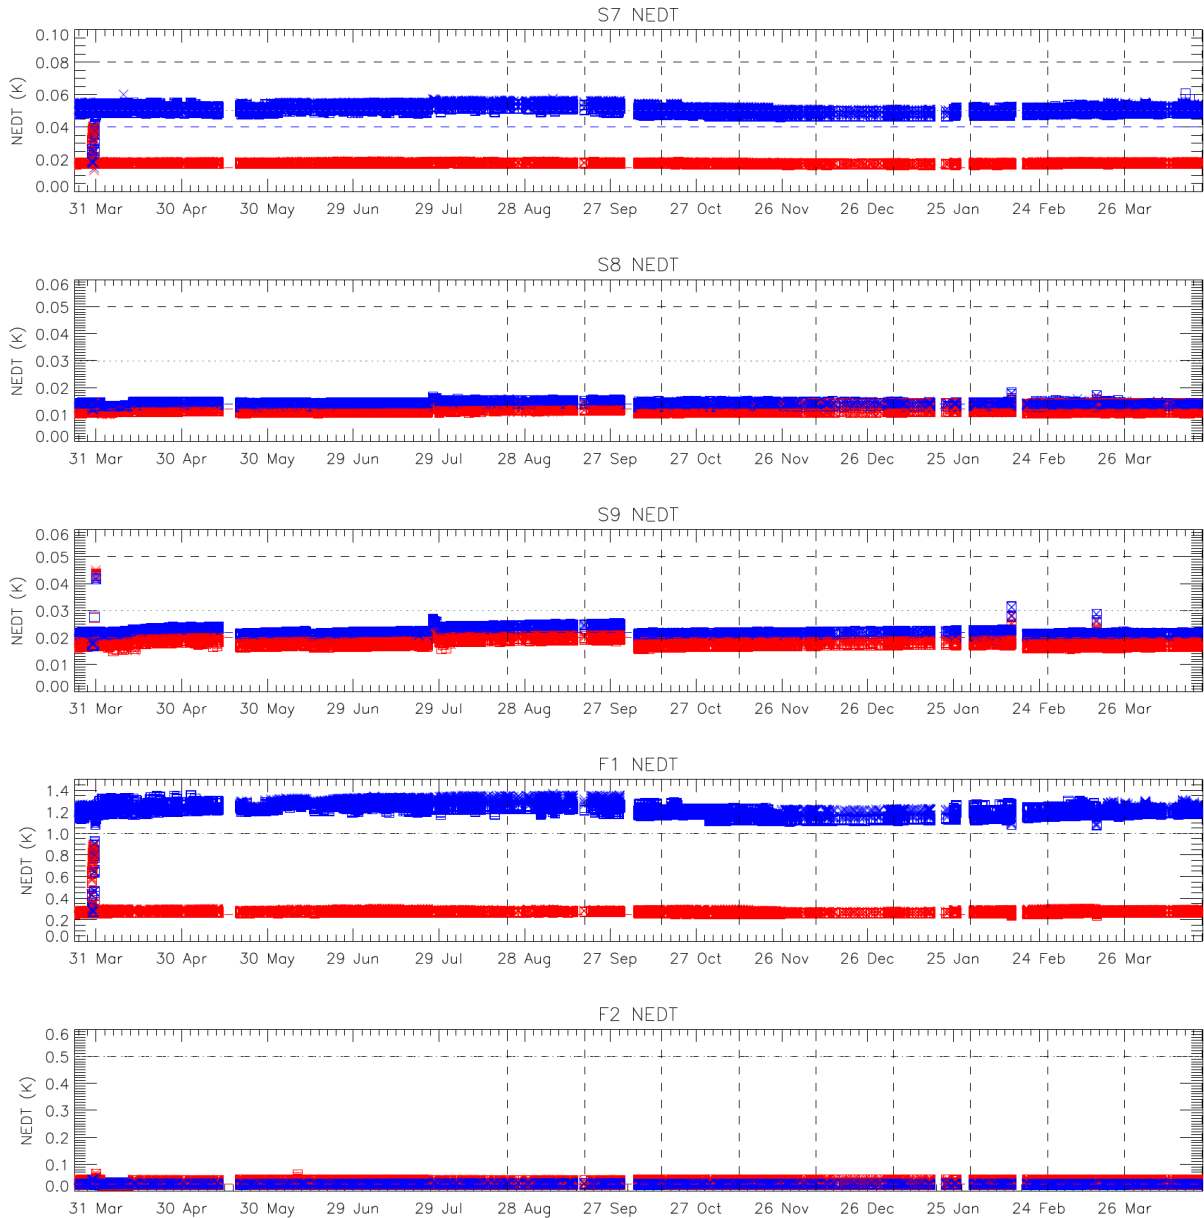
**Figure 8: NEDT trend for the thermal channels. Blue points were calculated from the cold blackbody signal and red points from the hot blackbody. Horizontal lines indicate the requirement (dashed) and goal (dotted) as well as the measured values on ground (red and blue dashed).**

The thermal channel NEDT values are consistent with previous operations and within the requirements.

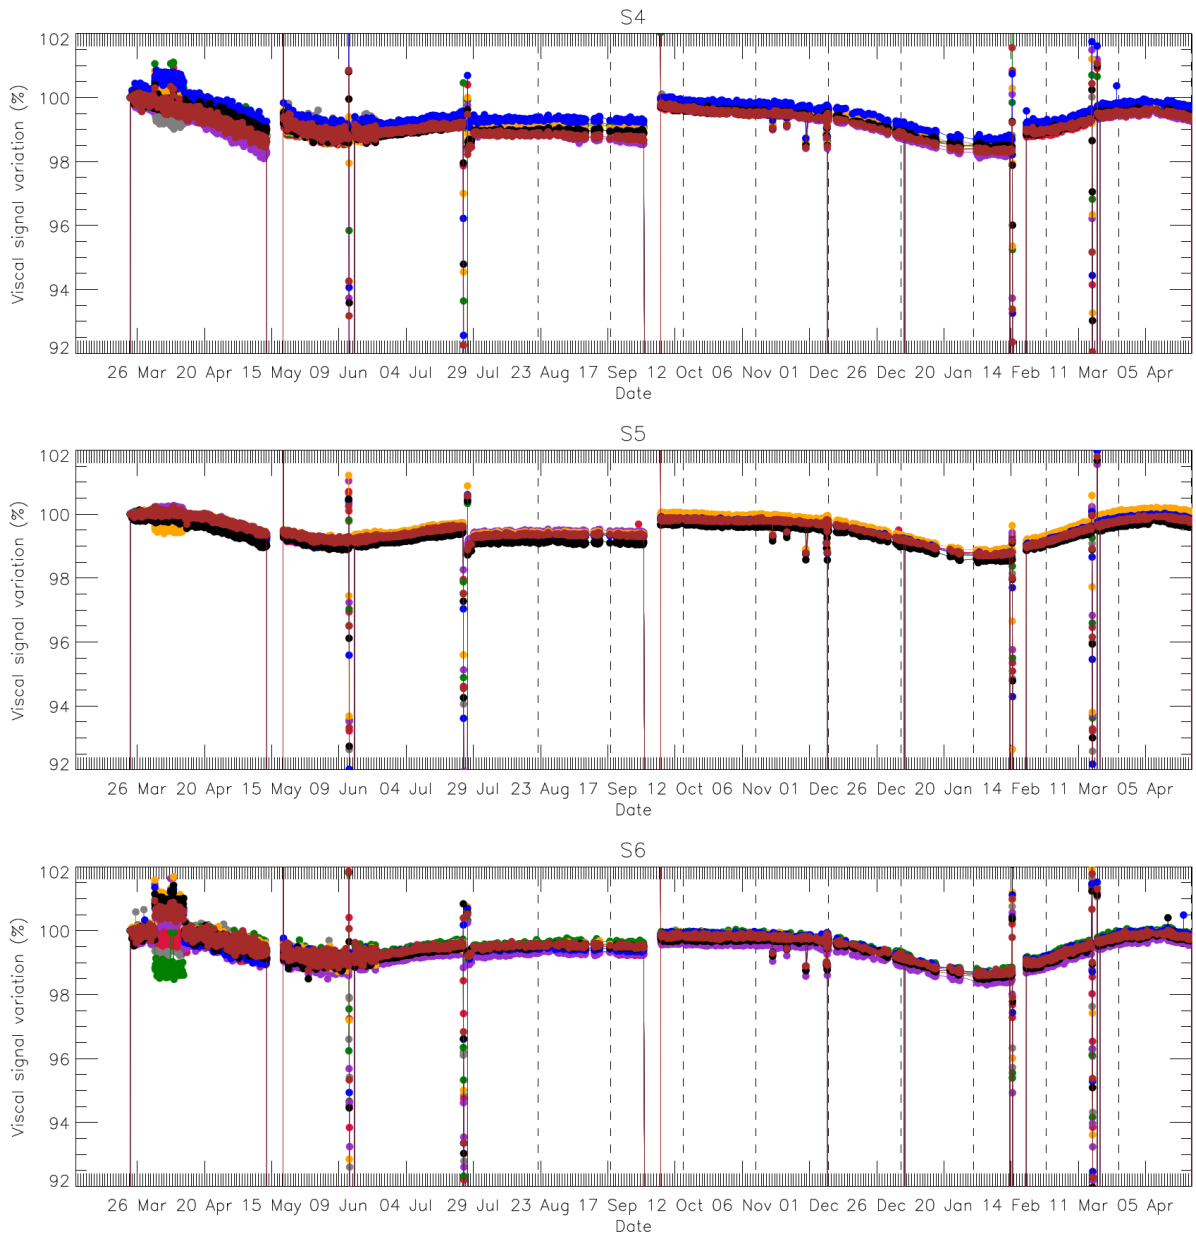
Figure 10: VISCAL signal trend for SWIR channels (nadir view).

Signals from the VISCAL source for the VIS channels show oscillations due to the build up of ice on the optical path within the FPA. Decontamination is carried out periodically, in order to warm up the FPA and remove the ice. The last decontamination cycle was successfully performed following the anomaly on 14<sup>th</sup> February. Following the anomaly on 16<sup>th</sup> March and the subsequent cooldown, the VISCAL signals have returned to their pre-anomaly levels and the oscillations in signal have continued from where they left off.
