SENTINEL 2

L1C Data Quality Report

Ref. S2-PDGS-MPC-DQR

Reference:	S2-PDGS-MPC-DQR
	Issue:	30
	Date:	04/08/2018

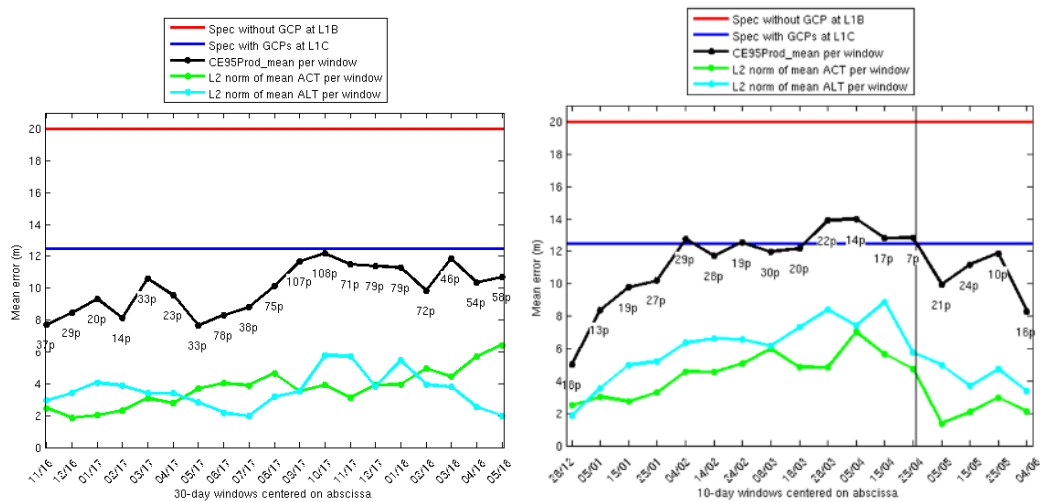
For S2A, the latest performance estimation (based on 430 products since June 2017) is close to 12 m at 95%. To regain the long-term performance of 11 m, an update of the geometric calibration is planned in the coming months.

Figure 1: Geolocation performance for S2A (left) and S2B (right). The performance is computed over a sliding window of 30 (resp. 10) days. Number of products used in the sliding window indicated for each point. (ACT= across track, ALT = along track). A vertical line indicates a geometric calibration event.

Note that the geolocation performance has a latitude-dependent component. This effect is particularly visible on the along-track component, and more pronounced for S2B than S2A. Images are shifted of 5 m Southward (approximately) in the Northern latitudes, to 5 m Northward in the Southern latitudes. This will be corrected with the introduction of the geometric refinement.

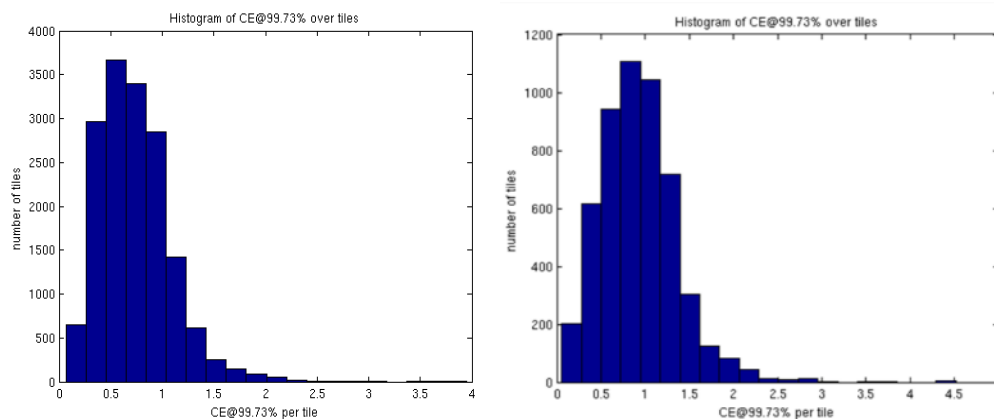
Figure 2: Histogram of the multi-temporal performance for S2A (left) and S2B (right, different scale). The 3 m requirement will be applicable only after activation of the geometrical refinement.
The current performance is 11 m (S2A) and 13 m (S2B) at 95% confidence.

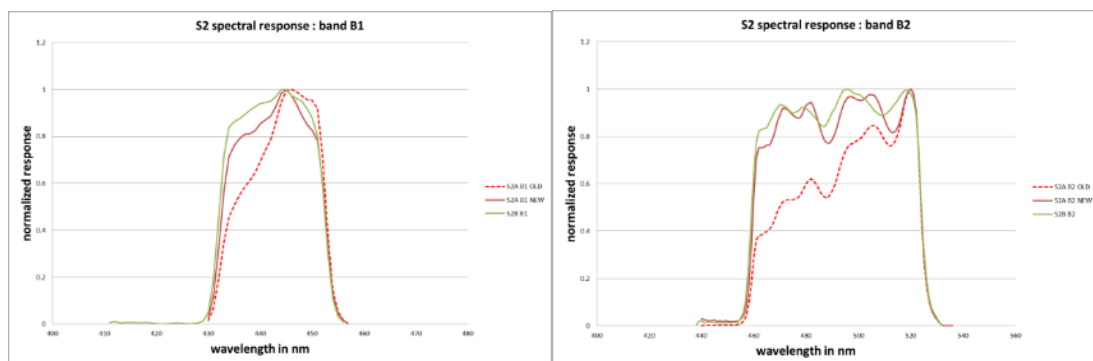
As mentioned in previous editions of the DQR, an anomaly was identified on the spectral response functions of S2A, affecting mostly bands B01, B02 and B08. This anomaly was corrected on January 15th 2018 (cf. https://cophub.copernicus.eu/news/News00138) in the product metadata.

Note that this issue has negligible impact on the radiometry of the L1C reflectance products. On the other hand the conversion to radiance values and the computation of downstream products relying on the spectral response function can be impacted (such as L2A products).

Figure 3: Spectral Response Functions for bands B01 and B02. Red – dashed: S2A before correction. Red – solid: S2A after correction. Green: S2B.

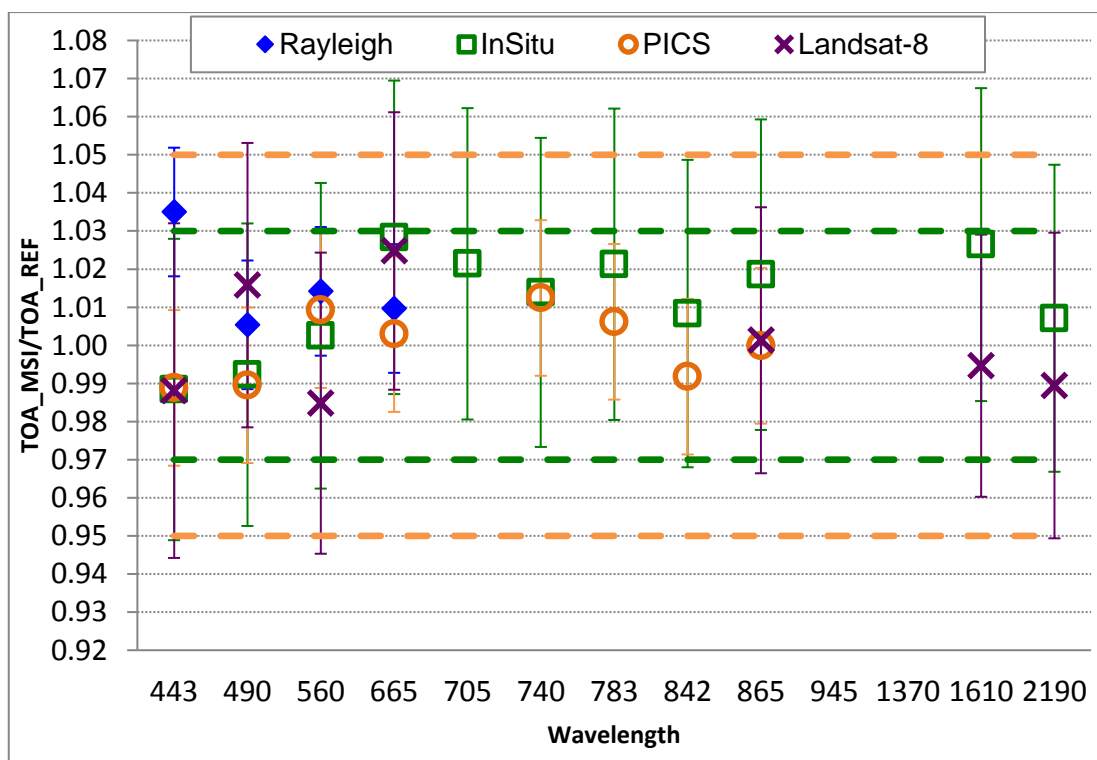
Figure 4: Comparison of radiometric accuracy for all spectral bands (except B10 and B09): ratio of S2A measurement on reference. Error bars indicate the method uncertainty.

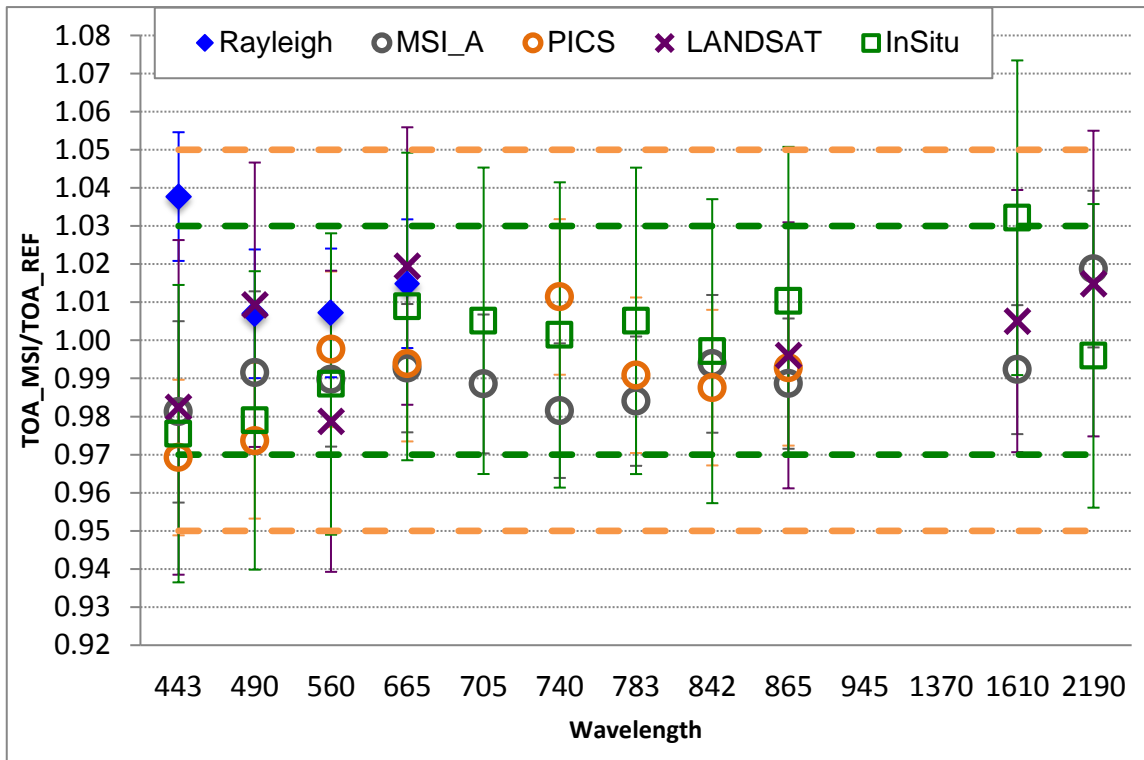
Figure 5: Comparison of radiometric accuracy for all spectral bands (except B09 & B10): ratio of S2B measurement on reference. Error bars indicate the method uncertainty.

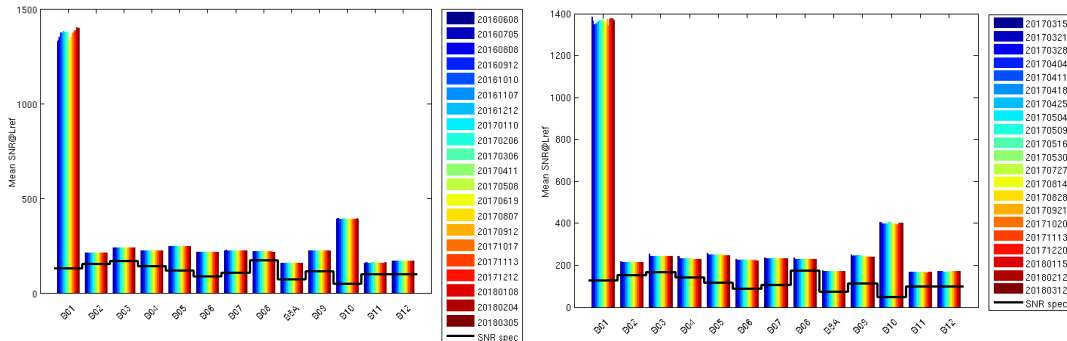
As seen in the figure below, the noise characteristics are very stable over time.

Figure 6: Evolution of the SNR performance or S2A since 08/06/2016 (left) and S2B since 15/03/2017 (right)

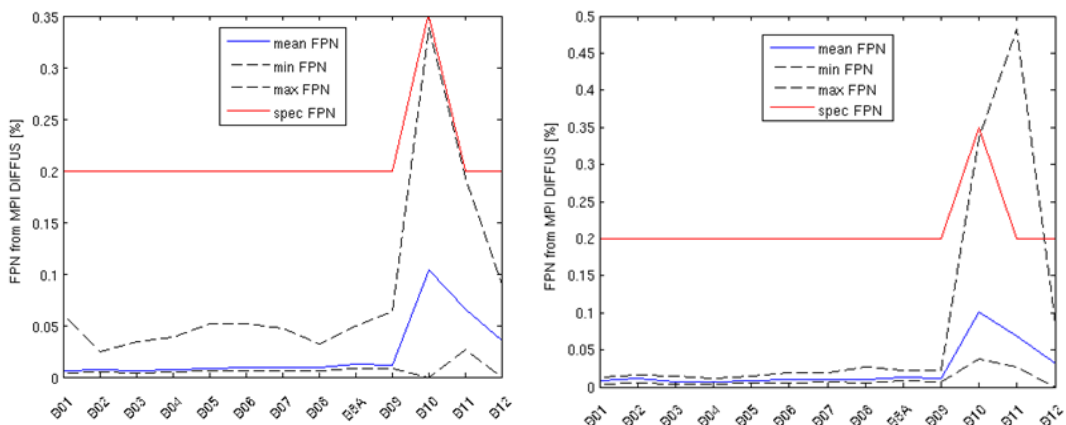
Another aspect of the image noise is the so-called Fixed Pattern Noise: this is the residual pixel radiometric error after equalization. The performance is better than the specification for all bands except for a few pixels on Bands B11 and B10.

Figure 7: Fixed Pattern Noise (residual error after equalization) measured on diffuser images for S2A (left) and S2B (right). Blue curve: mean FPN, red: maximum specified value. Dashed: best- and worst-case pixels.

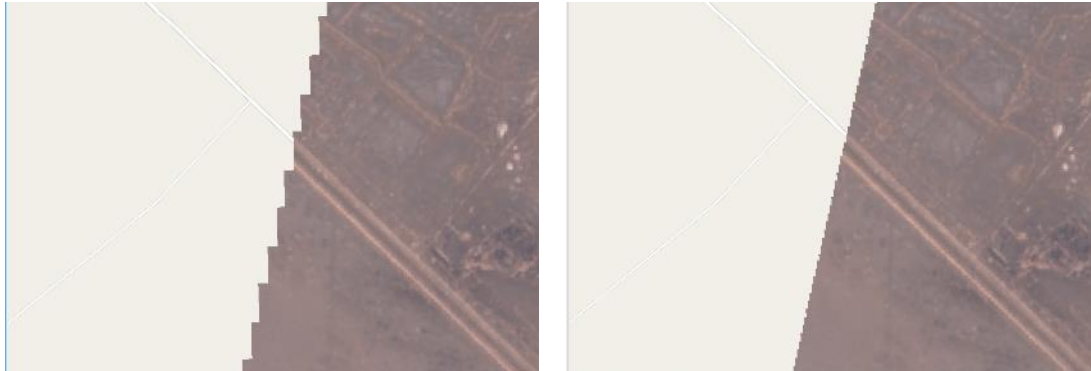
✓ **Straightening of image boundaries**. Currently the border of the swath shows a staircase pattern with a step size of 45 meter approximately. The evolution provides a straight boundary and increases the number of valid pixels.

Figure 8: Swath boundary with the current processing baseline 02.06 (Left) and new processing baseline 02.07 (Right). The coarse staircase-like boundary has been refined. More valid pixels are provided.

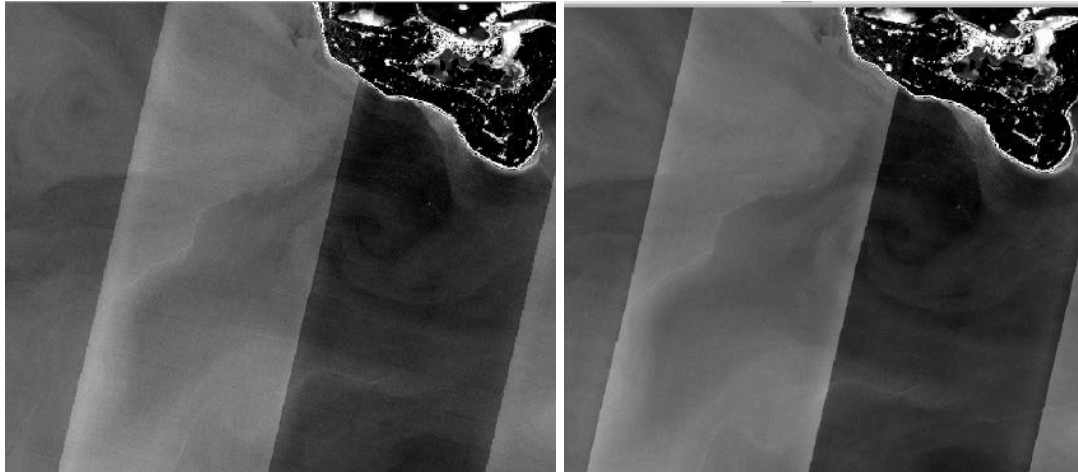
✓ **Improved dark current processing**. This evolution will remove the across-track noise that can be observed on some dark images (see paragraph 6.3 and figure below).

Figure 10: B01 image over sea with the current processing baseline 02.06 (Left) and the new processing baseline 02.07 (Right). Across-track lines due to correlated dark signal noise have been filtered.

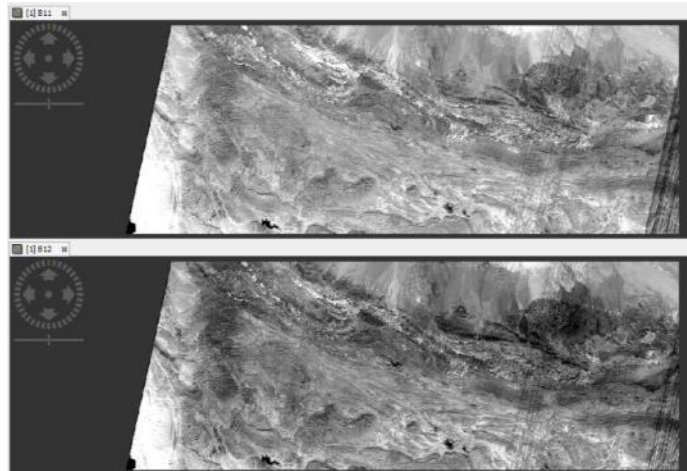
This anomaly is characterized by along-track stripes on some detectors of SWIR band images (see image below). Other detectors are also misaligned (along-track shift).

Figure 11: Striping of SWIR bands (anomaly #9). Top: B11, Bottom, B12.

This anomaly occurred during commissioning as a result of an incorrect instrument configuration. Users are advised to use only VISNIR bands for the corresponding orbits.

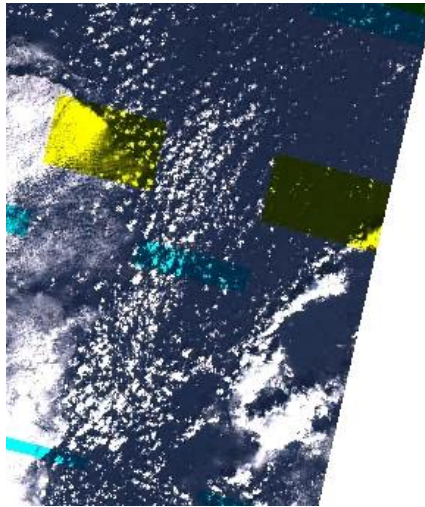
Data downlink issue sometimes lead to missing instrument source packets. This results in missing or corrupted pixels in L1C image, typically affecting only odd or even detectors and some spectral bands. The figure below presents an example of product affected by missing packets.

Figure 12: L1C product affected by a large number of missing packets. This type of feature is not considered as an anomaly and will not lead to removal of affected products.

Under the current quality control policy, this effect is not considered as an anomaly. Products affected by missing packets will remain in the archive.

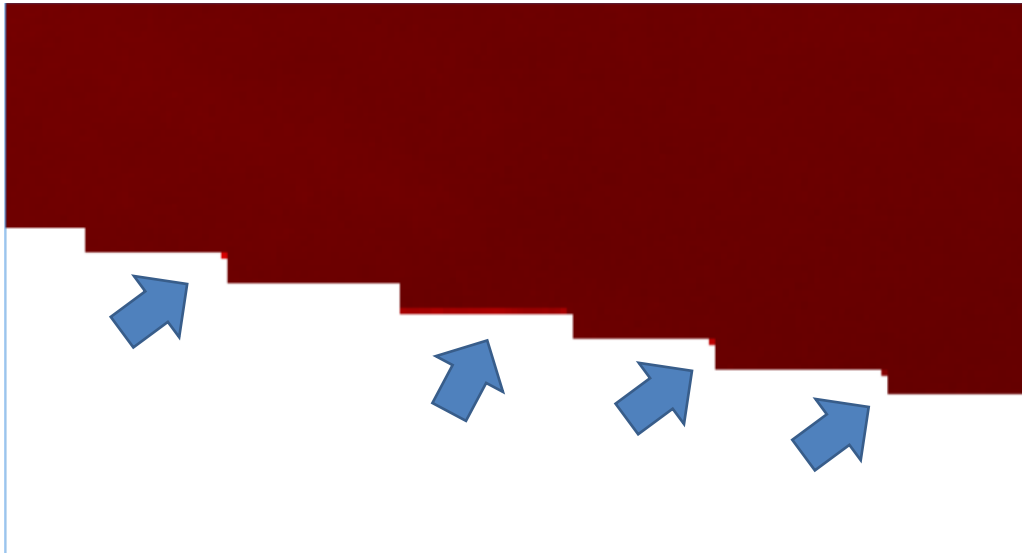
This anomaly is characterized by anomalous pixel values at the boundary of a datastrip. This anomaly has been corrected with baseline 02.02.

Figure 13: Anomalous pixels on band B4 (anomaly #12).

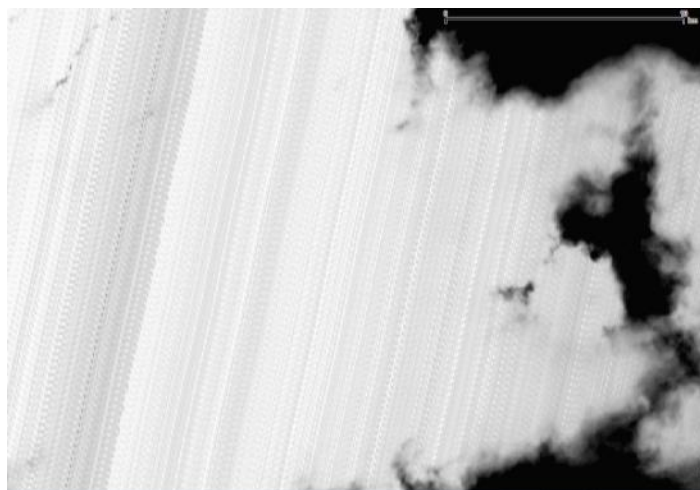
This feature is characterized by noise patterns on bright images. It has now been identified as generated by saturation of the detector. This effect is not an anomaly in itself, however the saturation is currently not correctly reported in the image quality masks. A modification of the processor is in progress to solve this issue.

Figure 14: Along-track noise pattern on B10 images over bright clouds (#13).

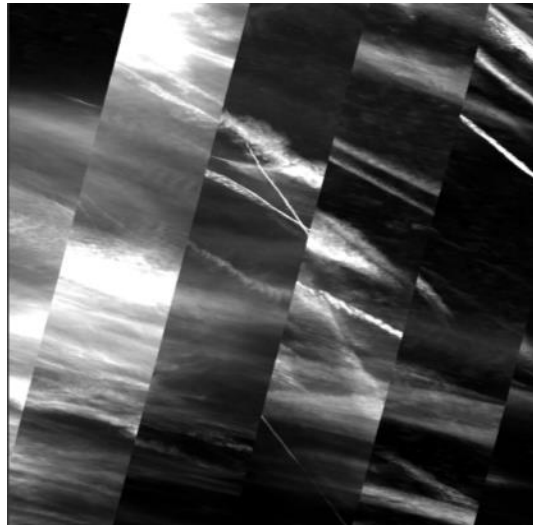
This anomaly is characterized by an incorrect appearance of the 60 m bands: images are stretched across-track and discontinuities are visible between detector boundaries. A few occurrences have been observed, and none since 27/04/2016.

Figure 16: Stretching of 60 m bands (anomaly #16).

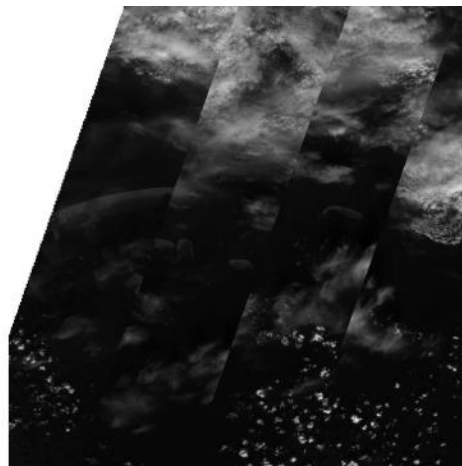
An anomaly on the receiving ground station occurred on 12[th] of July 2016 and led to corrupted products for a few orbits (5509 to 5525). The anomaly affects only band 1 and is limited the first products for the datastrips (Northern part). It is characterized by a misalignment of the odd and even detectors, as illustrated in the figure below.

Figure 17: Detector misalignment on band B1 (anomaly #17).

A possible correction of this anomaly by an ad-hoc reprocessing is under study.

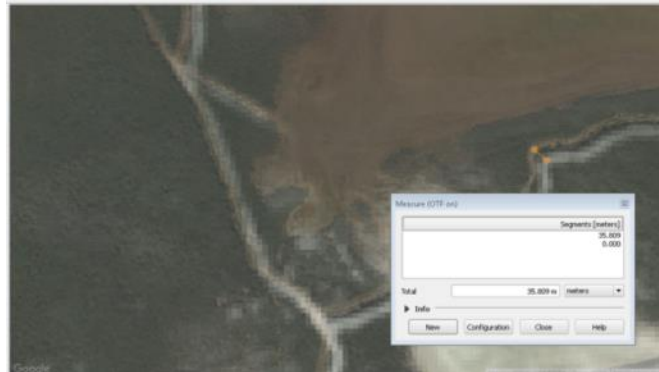
This anomaly occurred while the satellite was performing a collision avoidance manoeuvre on 16[th] August 2016. One Star Tracker was temporarily blinded by the Sun, which led to a degradation of the attitude estimation. As a result, the geolocation of the products acquired during this period (orbits 6003 to 6011) is affected by a variable geolocation error of up to 100 meters.

The anomaly is related to the handling of the redundant Star Tracker in the attitude estimation system. A correction of the alignment of the redundant Star Tracker is planned to avoid a re-occurrence of this anomaly.

Figure 18: S2 image superimposed with reference map, showing a geolocation error of 35 m (anomaly #18).

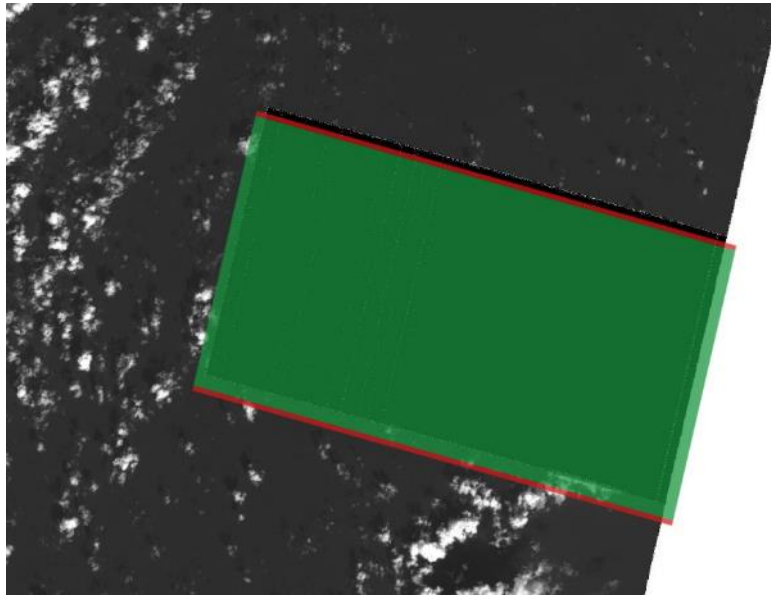
Since October 2016, technical quality masks (TECQA) are reporting instance of lost data packets (see anomaly #10). However it has been found that the masks are not perfectly accurate (see figure below). This anomaly is essentially corrected with production baseline 02.05. Some residual errors have been observed, which led to a further improvement deployed the 07/06/2018.

Figure 19: Technical Quality masks (green: lost packets, red: degraded packets) overlayed over an affected imaged. A small gap exists between the mask and the affected area (anomaly #21).

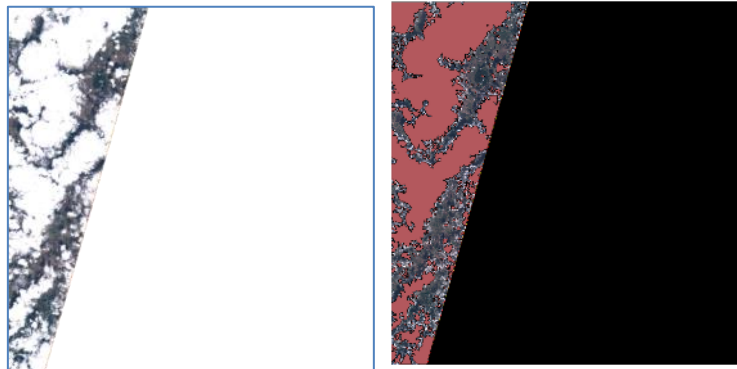
Figure 20: Tile 40UGE acquired on 12/06/2018 by S2B. Left: RGB composite, Right: cloud mask (in red). The cloud coverage percentage is incorrectly reported as 19.3% (anomaly #44).

A correction has been implemented and will be deployed in the coming weeks.

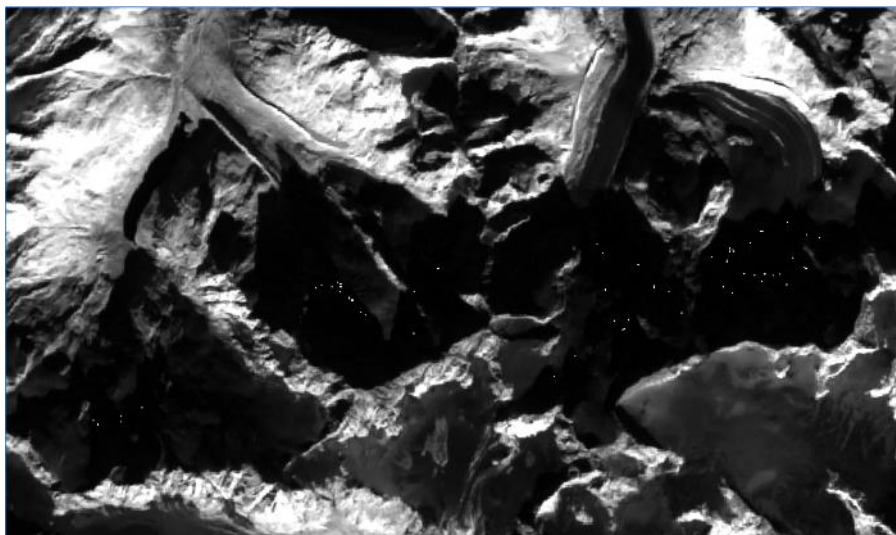
Until product baseline 02.01, several products had valid pixels with a reflectance value of 0 (No Data) instead of 1 (minimal reflectance). This anomaly was essentially fixed with baseline 02.01, however some products have been found recently which are still affected. The anomaly affects a few pixels in very dark areas (e.g. topographic shadows on SWIR bands).

Figure 21: Pixels with 0 value (No Data) shown here as transparent, in a dark area of a B12 image (Anomaly #5).

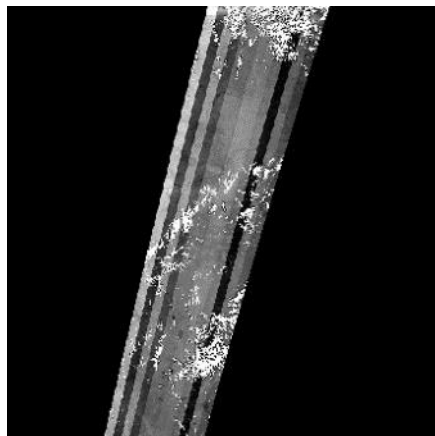
Since 18/07/2018, equalization issues have been observed on S2A products. The issue is especially visible on Band 10 if the contrast is enhanced. This issue also affects the cirrus cloud mask which may exhibit discrepancies between detectors. Note that the impact on the radiometry is limited to a few percent. This issue is currently under investigation and a remediation is expected in the coming days.

Figure 22: Incorrect equalization of B10 for S2A (anomaly #45).

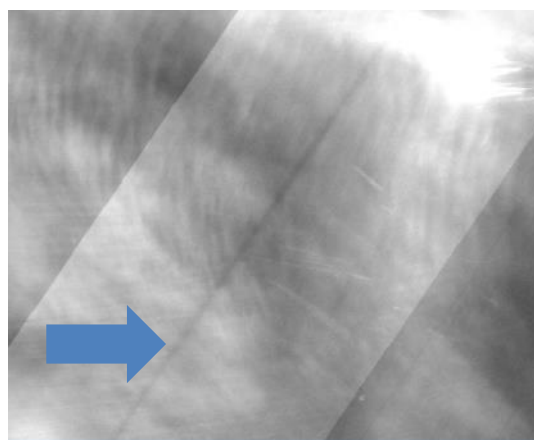
In addition to the defective pixels listed above, a group of pixels (570 to 600) of Band 11 D11 are affected by a non-linear radiometric response. This effect generates a darker along-track area in dark B11 images (e.g. on snow, see figure below).

Figure 24: Along-track stripe on B11 image due to a non-linear response on D11 (contrast strongly enhanced).

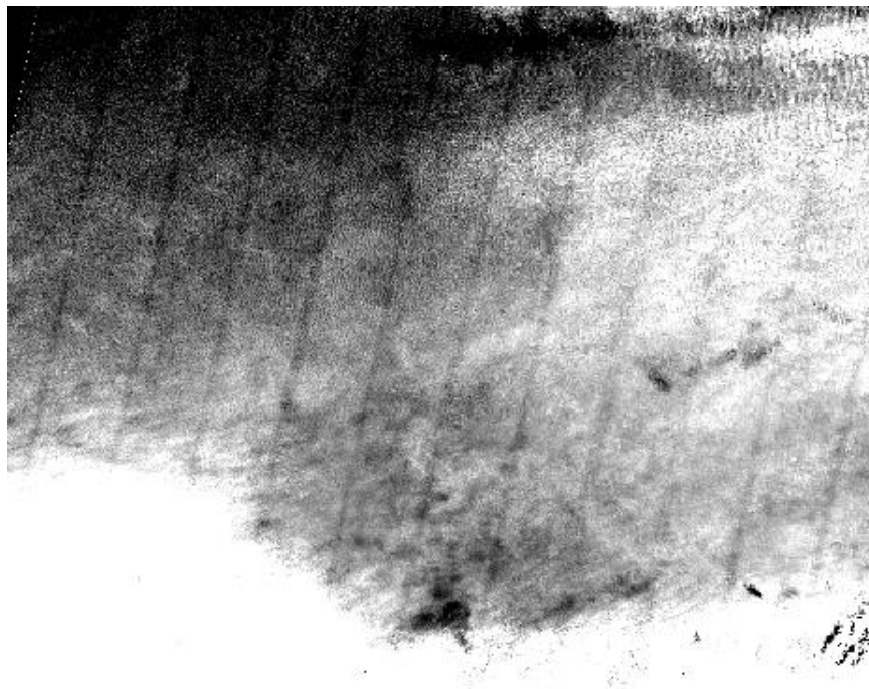
This feature is characterized by along-track soft-edged darker or brighter stripes near the detector boundaries, as shown on the figure below. Indeed, the spectral response is slightly different at the edges of the detectors, especially for bands B03 and B05. When the spectrum of the scene has strong gradient over the spectral bandwidth of the detector, a difference in the measured radiometry can be observed (up to 2% in worst-cases).

Figure 25: Along-track stripes resulting from spectral response non-uniformity (band B03).

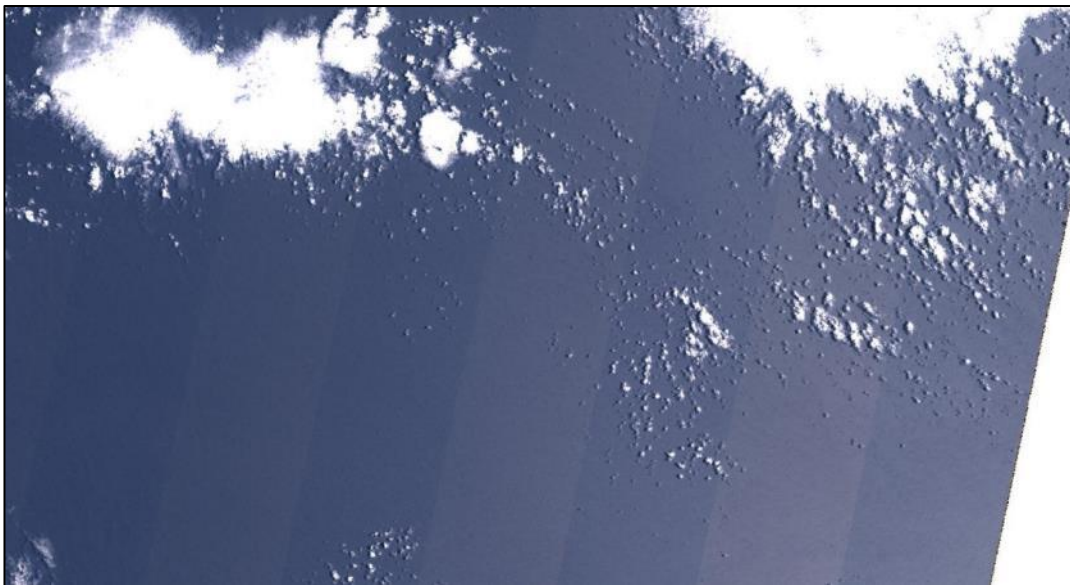
Because the viewing angles are not the same for even and odd detectors, differences in measured radiometry can be observed on non-Lambertian surfaces. This is especially visible on Sun glint over sea surfaces (see Figure below).

Figure 26: Stripe pattern over sea surface, due to the observation parallax effect between odd and even detectors.

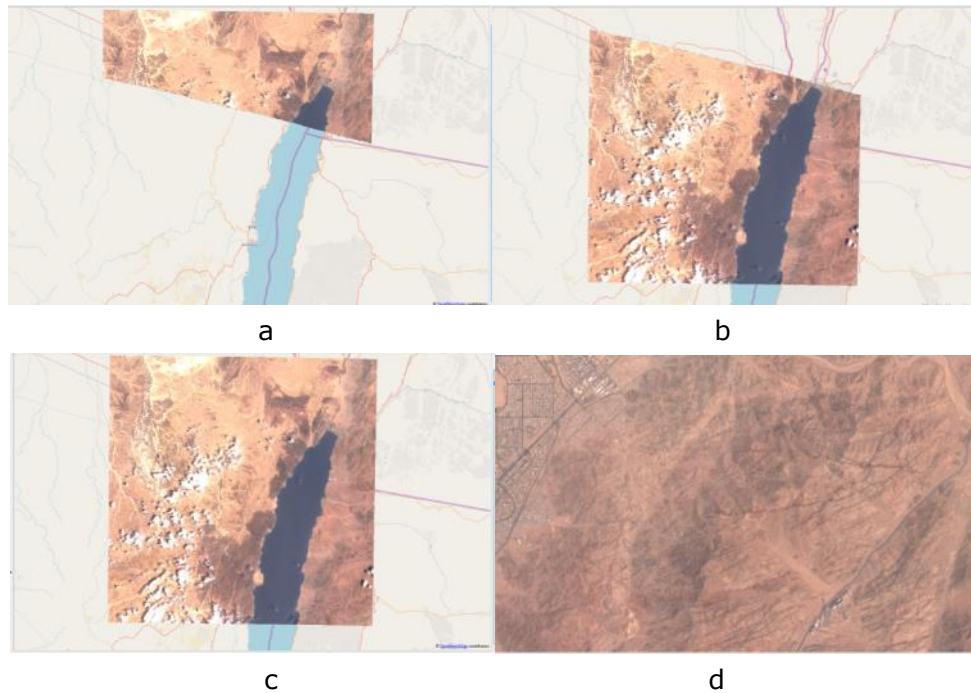
Figure 30: Example of a pair of products at the overlap between two data-strips. a: product from the first data-strip, processed at Svalbard (SGS) b: product from the second data-strip, processed at Matera (MTI). c: the two products overlap seamlessly to reconstruct the complete acquisition. d: close-up near the transition line.
