Reference: S2-PDGS-MPC-DQR
Issue: 33
Date: 07/11/2018

S2 MPC

L1C Data Quality Report

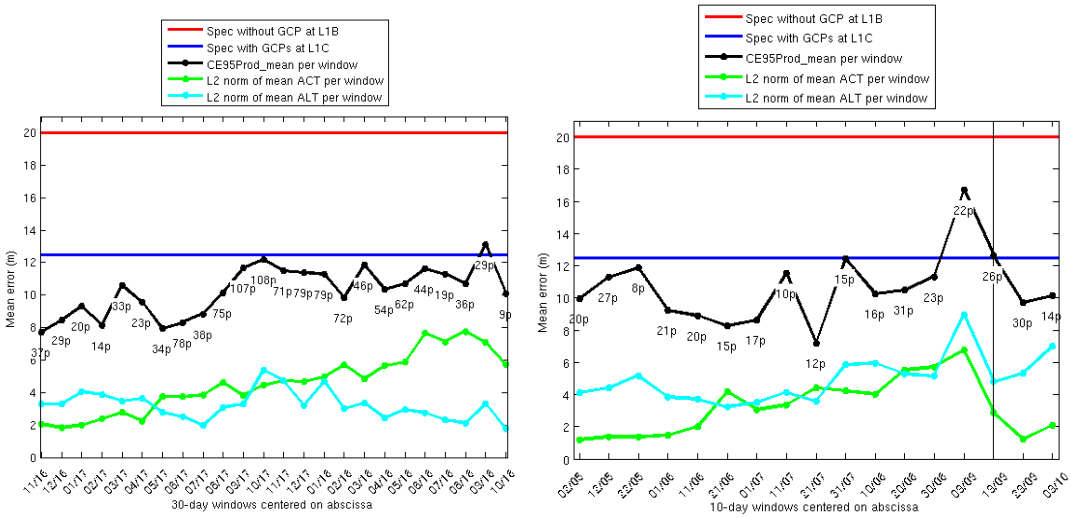
Absolute geolocation is constantly monitored for S2A and S2B. The long-term performance is close to 11 m at 95% for both satellites.

The performance for S2B reported below shows the improvement carried out with the calibration of September 2018.

Figure 1: Geolocation performance for S2A (left) and S2B (right). The performance is computed over a sliding window of 30 days (S2A, left) or 10 days (S2B, right). Number of products used in the sliding window indicated for each point. (ACT= across track, ALT= along track). A vertical line indicates a geometric calibration event.

Note that the geolocation performance has a latitude-dependent component. This effect is particularly visible on the along-track component, and more pronounced for S2B than S2A. Images are shifted of 5 m Southward (approximately) in the Northern latitudes, to 5 m Northward in the Southern latitudes. This will be corrected with the introduction of the geometric refinement.

A new geometric calibration has been implemented on 18/09/2018 to cope with a rapid evolution of the pointing biases observed during the month of September. S2B geometric performance has returned to normal after this update.

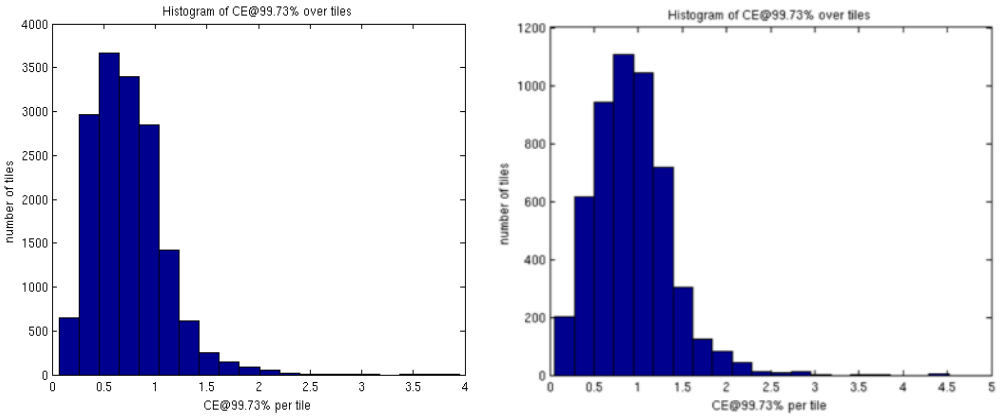
The multi-temporal registration error for one tile is estimated as the mean measured error for all control points of the tile. Then the global performance is taken as the 95.5% percentile of the value for all tiles measured on the reference band (B04). According to this methodology, the current performance is around 12 m. Figure 2 shows the histogram of the distribution of multi-temporal registration errors for S2A and S2B respectively. Table 3 present the observed statistical distribution of the observed multi-temporal registration performance for S2A and S2B products (separately and with respect to each other).

**Figure 2: Histogram of the multi-temporal performance for S2A (left) and S2B (right, different scale). The 3 m requirement will be applicable only after activation of the geometrical refinement.
The current performance is 11 m (S2A) and 13 m (S2B) at 95% confidence.**

It is recalled that the objective is to meet the required 3 m performance (95.5% confidence level) with the activation of the geometric refinement using the GRI.

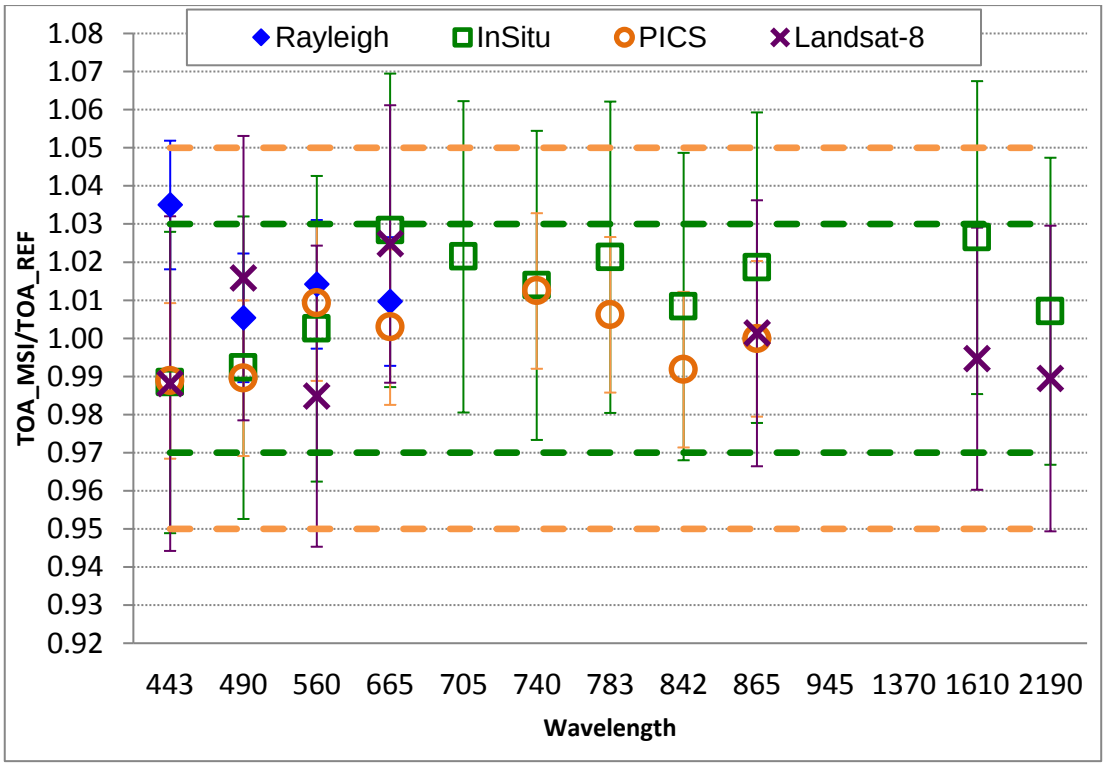
A small systematic difference in radiometry is observed between S2A and S2B:

S2A is brighter (measured reflectance higher) than S2B by about 1%. This difference is currently under study.

Figure 3: Comparison of radiometric accuracy for all spectral bands (except B10 and B09): ratio of S2A measurement on reference. Error bars indicate the method uncertainty.

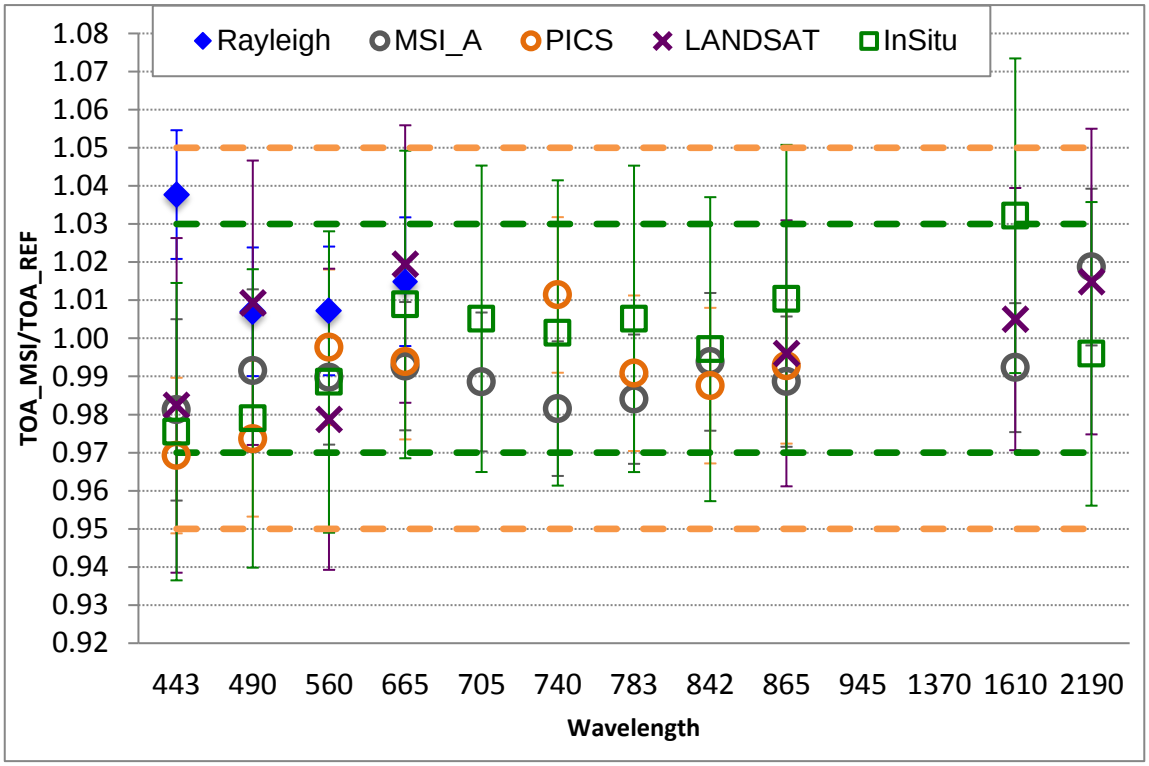
Figure 4: Comparison of radiometric accuracy for all spectral bands (except B09 & B10): ratio of S2B measurement on reference. Error bars indicate the method uncertainty.

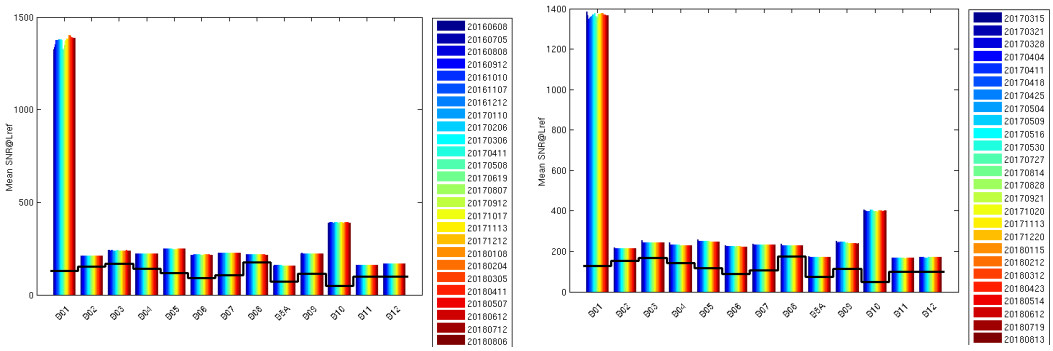
As seen in the figure below, the noise characteristics are very stable over time.

Figure 5: Evolution of the SNR performance or S2A since 08/06/2016 (left) and S2B since 15/03/2017 (right)

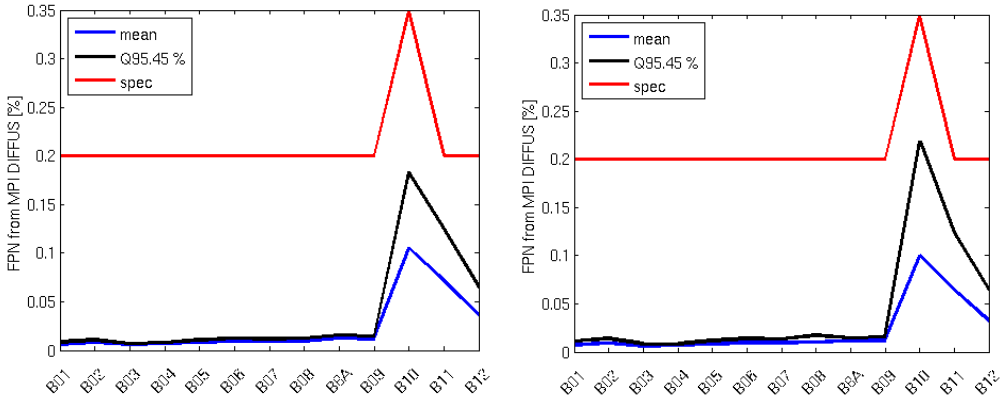
Another aspect of the image noise is the so-called Fixed Pattern Noise: this is the residual pixel radiometric error after equalization. The performance is better than the specification for all bands except for a few pixels on Bands B11 and B10.

Figure 6: Fixed Pattern Noise (residual error after equalization) measured on diffuser images for S2A (left) and S2B (right). Blue curve: mean FPN, black: 95 percentile, red: specified value.

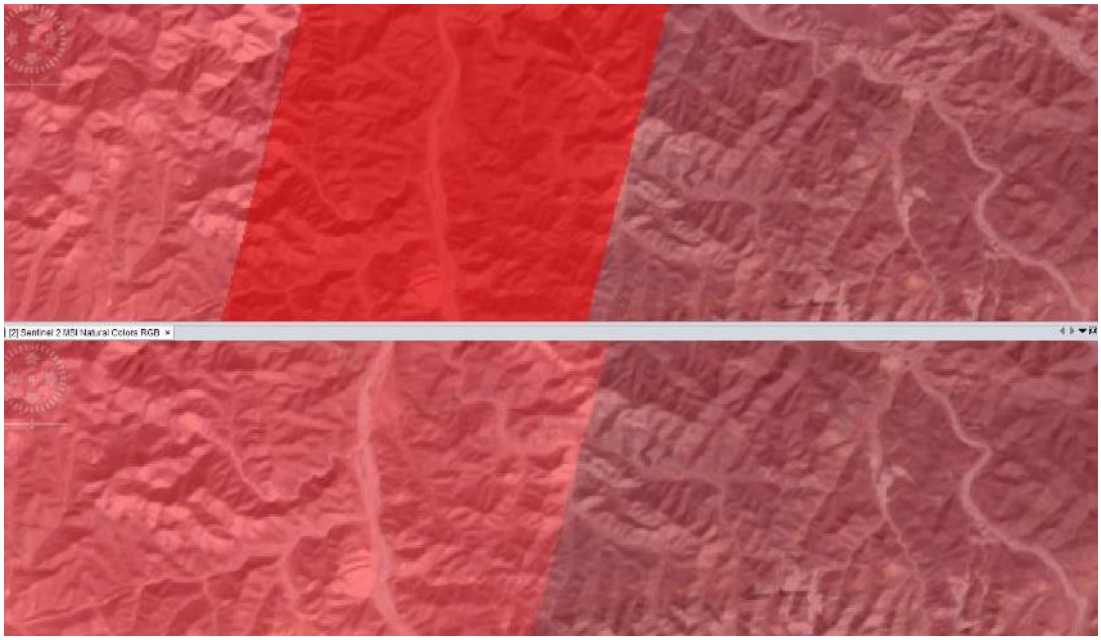
Figure 8: Detector footprints for the current processing baseline 02.06 (top) and new processing baseline 02.07 (bottom). The detector footprint do no longer include the overlap area.

✓ **Accurate detector footprint mask**. The overlap area between detectors has been removed, which provides the exact location of the interface.

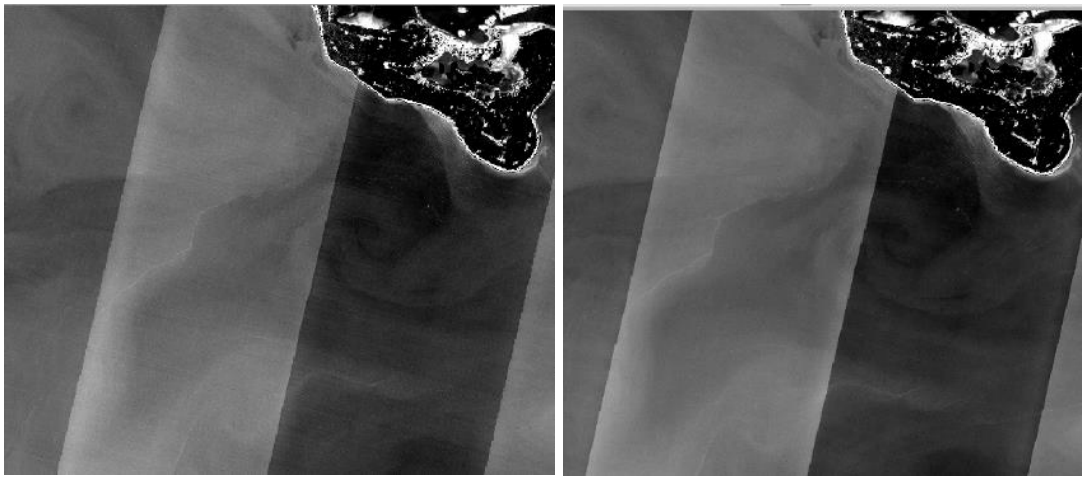
Figure 9: B01 image over sea with the current processing baseline 02.06 (Left) and the new processing baseline 02.07 (Right). Across-track lines due to correlated dark signal noise have been filtered.

✓ **Improved dark current processing**. This evolution removes the across-track noise that can be observed on some dark images (see paragraph 6.3 and figure below).

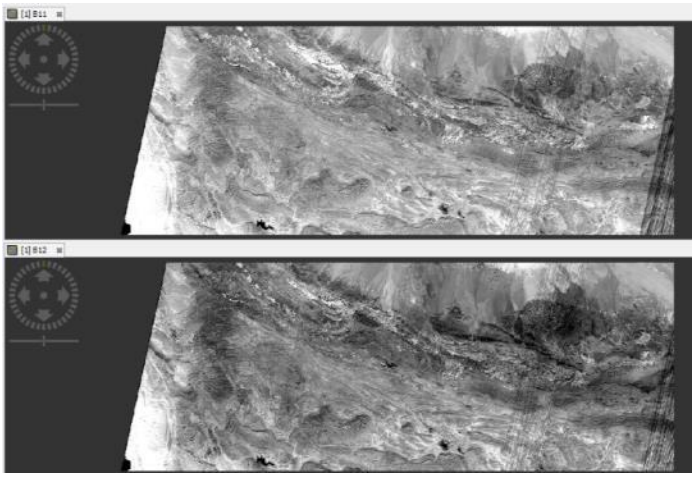
This anomaly is characterized by along-track stripes on some detectors of SWIR band images (see image below). Other detectors are also misaligned (along-track shift).

Figure 10: Striping of SWIR bands (anomaly #9). Top: B11, Bottom, B12.

This anomaly occurred during commissioning as a result of an incorrect instrument configuration. Users are advised to use only VISNIR bands for the corresponding orbits.

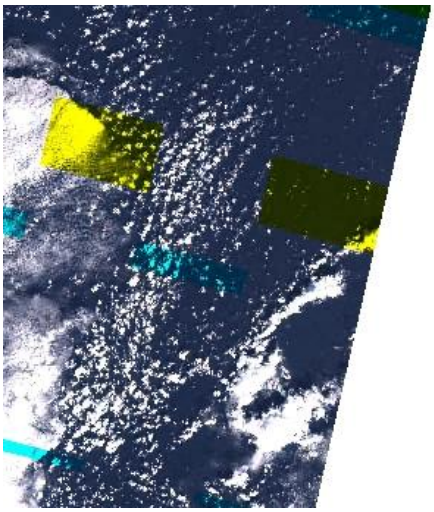
Data downlink issue sometimes lead to missing instrument source packets. This results in missing or corrupted pixels in L1C image, typically affecting only odd or even detectors and some spectral bands. The figure below presents an example of product affected by missing packets.

Figure 11: L1C product affected by a large number of missing packets. This type of feature is not considered as an anomaly and will not lead to removal of affected products.

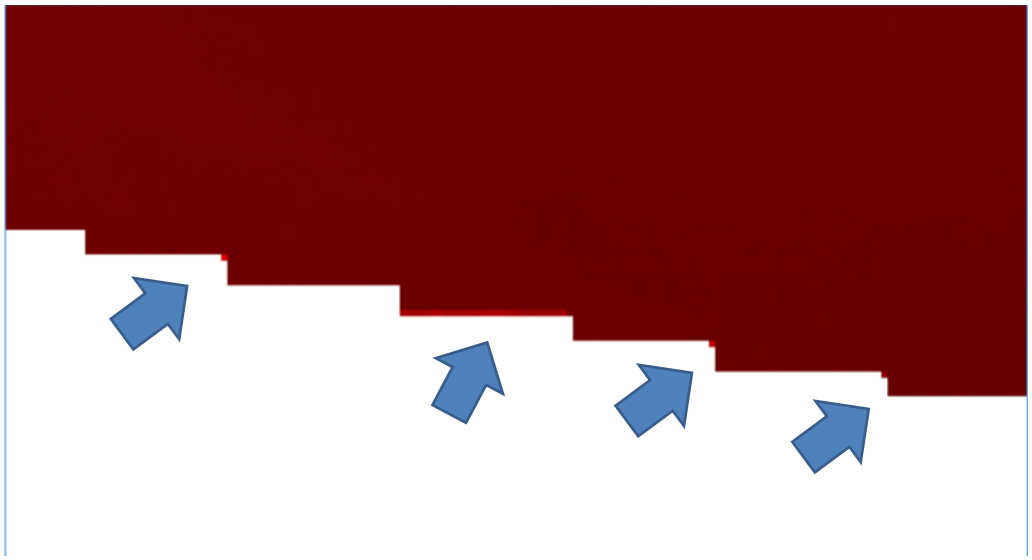
This anomaly is characterized by anomalous pixel values at the boundary of a datastrip. This anomaly has been corrected with baseline 02.02.

Figure 12: Anomalous pixels on band B4 (anomaly #12).

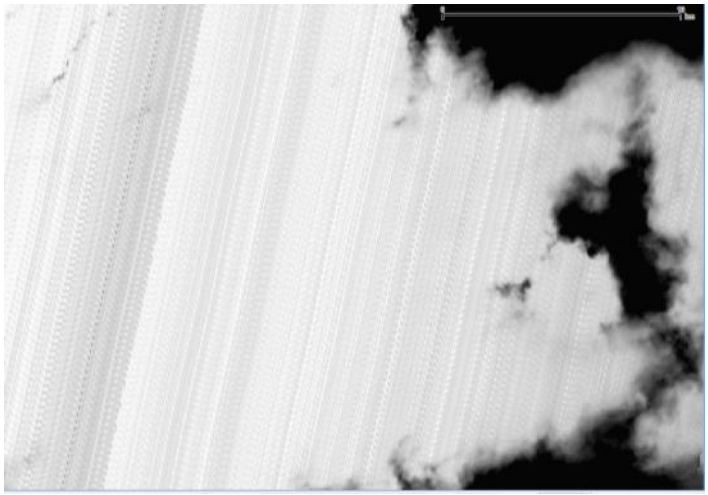
This feature is characterized by noise patterns on bright images. It has now been identified as generated by saturation of the detector. This effect is not an anomaly in itself, however the saturation is currently not correctly reported in the image quality masks. A modification of the processor is in progress to solve this issue.

Figure 13: Along-track noise pattern on B10 images over bright clouds (#13).

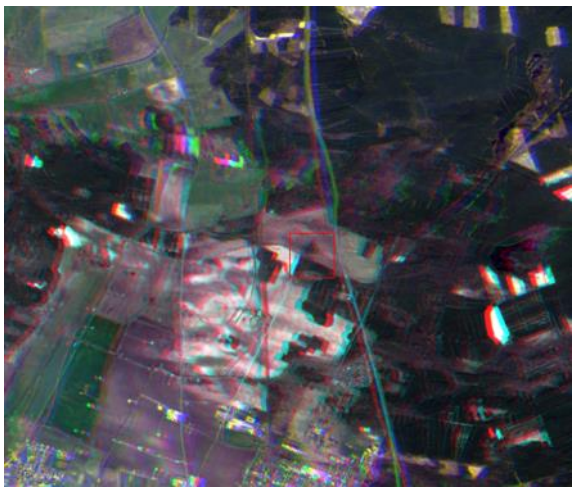
A major anomaly has led to a strong and temporary geolocation and spectral registration errors. The anomaly occurred on February 3rd (orbit 3218) and 3rd of April 2016 (orbits 4080, 4081 and 4082). This anomaly has been correctly identified by the automatic on-line quality control and the degraded geometric performance is reported in the product metadata (geometric quality check status is "FAILED"). After identification of the anomaly, the defective products have been removed from the public archive.

The root cause of this anomaly has been identified. Missing data from attitude control telemetry is at the origin of the anomaly. An optimization of the management of the on-board telemetry has been implemented since and should avoid any re-occurrence.

Figure 14: Spectral co-registration error (anomaly #14).

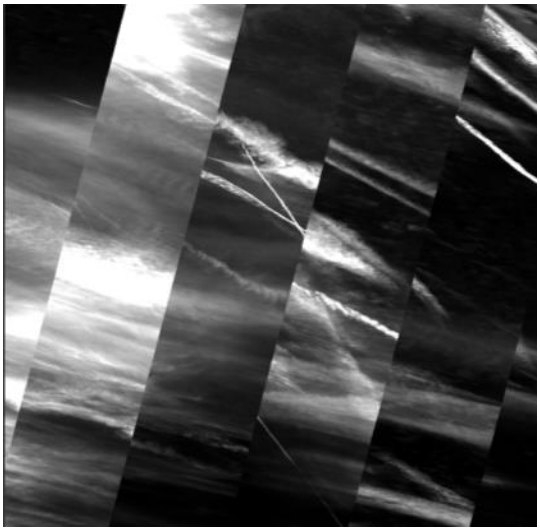
This anomaly is characterized by an incorrect appearance of the 60 m bands: images are stretched across-track and discontinuities are visible between detector boundaries. A few occurrences have been observed, and none since 27/04/2016.

Figure 15: Stretching of 60 m bands (anomaly #16).

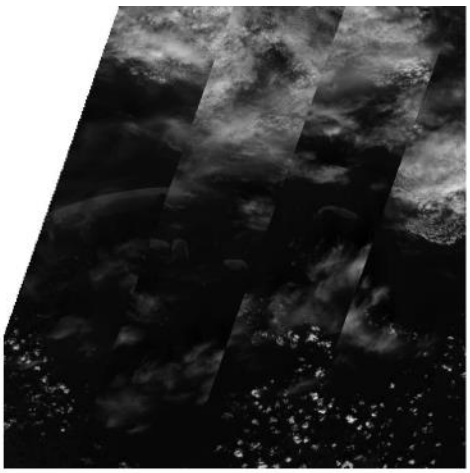
An anomaly on the receiving ground station occurred on 12th of July 2016 and led to corrupted products for a few orbits (5509 to 5525). The anomaly affects only band 1 and is limited the first products for the datastrips (Northern part). It is characterized by a misalignment of the odd and even detectors, as illustrated in the figure below.

Figure 16: Detector misalignment on band B1 (anomaly #17).

A possible correction of this anomaly by an ad-hoc reprocessing is under study.

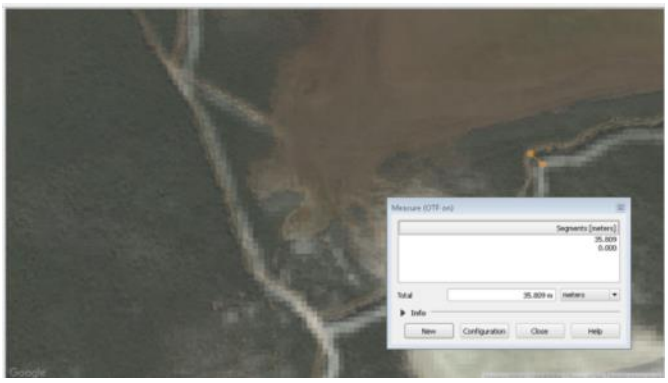
This anomaly occurred while the satellite was performing a collision avoidance manoeuvre on 16th August 2016. One Star Tracker was temporarily blinded by the Sun, which led to a degradation of the attitude estimation. As a result, the geolocation of the products acquired during this period (orbits 6003 to 6011) is affected by a variable geolocation error of up to 100 meters.

The anomaly is related to the handling of the redundant Star Tracker in the attitude estimation system.

Figure 17: S2 image superimposed with reference map, showing a geolocation error of 35 m (anomaly #18).

A correction of the alignment of the redundant Star Tracker is planned to avoid another re-occurrence of this anomaly.

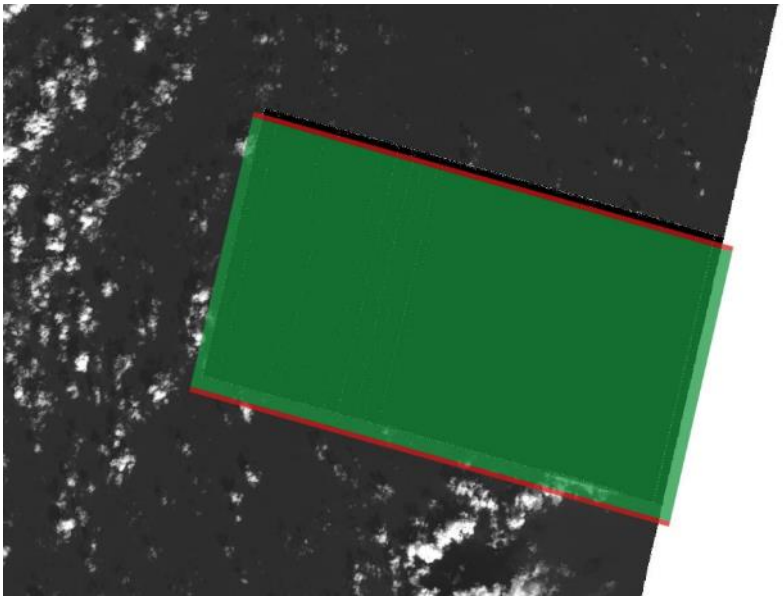
Since October 2016, technical quality masks (TECQA) are reporting instance of lost data packets (see anomaly #10). However, it has been found that the masks are not perfectly accurate (see figure below). This anomaly is essentially corrected with production baseline 02.05. Some residual errors have been observed, which led to a further improvement deployed the 07/06/2018.

Figure 18: Technical Quality masks (green: lost packets, red: degraded packets) overlaid over an affected image. A small gap exists between the mask and the affected area (anomaly #21).

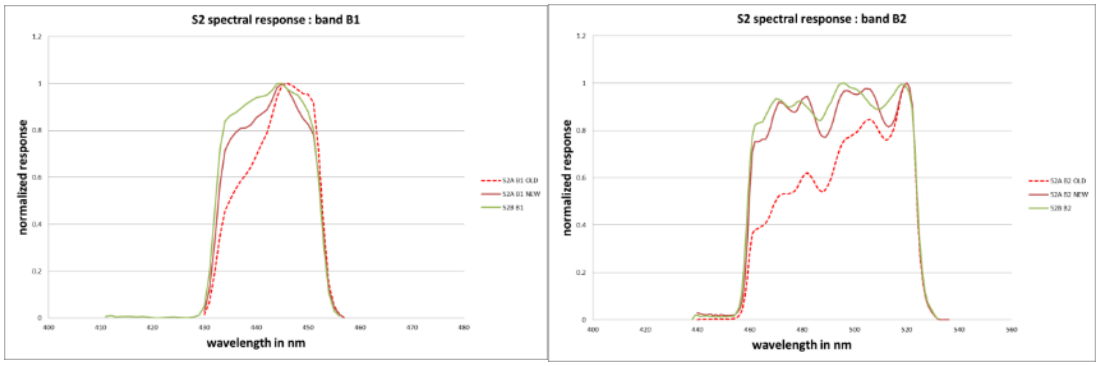
Note that this issue has negligible impact on the radiometry of the L1C reflectance products. On the other hand, the conversion to radiance values and the computation of downstream products relying on the spectral response function can be impacted (such as L2A products).

Figure 19: Spectral Response Functions for bands B01 and B02. Red – dashed: S2A before correction. Red – solid: S2A after correction. Green: S2B.

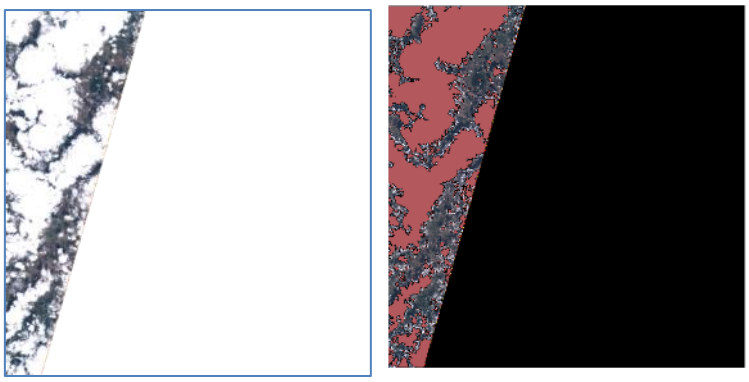
Since the Sentinel Data Hub uses this metadata to record catalogue entries, requests using filtering on cloud percentage can be affected.

On the other hand, the cloud mask itself is correct.

Figure 20: Tile 40UGE acquired on 12/06/2018 by S2B. Left: RGB composite, Right: cloud mask (in red). The cloud coverage percentage is incorrectly reported as 19.3% (anomaly #44).

Anomaly #44 is corrected with baseline 02.07.

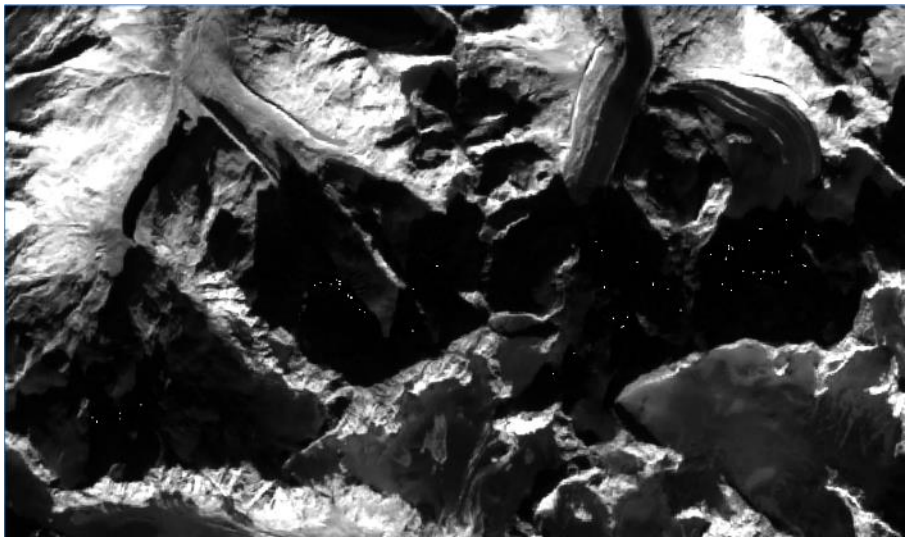
Until product baseline 02.01, several products had valid pixels with a reflectance value of 0 (No Data) instead of 1 (minimal reflectance). This anomaly was essentially fixed with baseline 02.01. However, errors induced by compression noise can still be found on very dark areas (e.g. over topographic shadows or water on SWIR bands).

Figure 21: Pixels with 0 value (No Data) shown here as transparent, in a dark area of a B12 image (Anomaly #5).

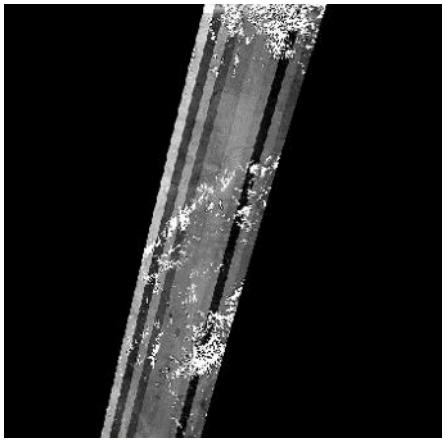
Since 18/07/2018, equalization issues have been observed on S2A products. The issue is especially visible on Band 10 if the contrast is enhanced. This issue also affects the cirrus cloud mask which may exhibit discrepancies between detectors. Note that the impact on the radiometry is limited to a few percent. The anomaly has been corrected on 30/07/2018.

Figure 22: Incorrect equalization of B10 for S2A (anomaly #45).

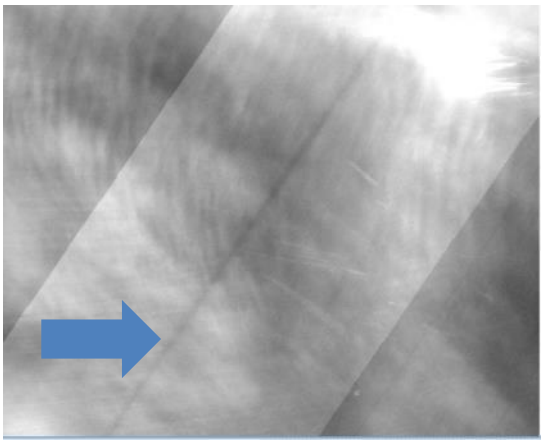
In addition to the defective pixels listed above, a group of pixels (570 to 600) of Band 11 D11 are affected by a non-linear radiometric response. This effect generates a darker along-track area in dark B11 images (e.g. on snow, see figure below).

Figure 24: Along-track stripe on B11 image due to a non-linear response on D11 (contrast strongly enhanced).

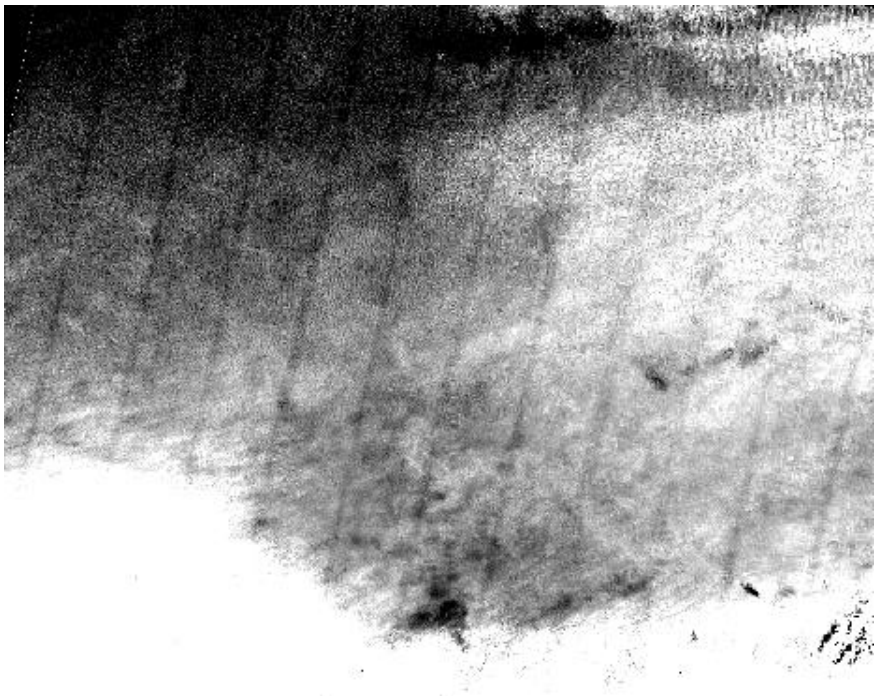
This feature is characterized by along-track soft-edged darker or brighter stripes near the detector boundaries, as shown on the figure below. Indeed, the spectral response is slightly different at the edges of the detectors, especially for bands B03 and B05. When the spectrum of the scene has strong gradient over the spectral bandwidth of the detector, a difference in the measured radiometry can be observed (up to 2% in worst-cases).

Figure 25: Along-track stripes resulting from spectral response non-uniformity (band B03).

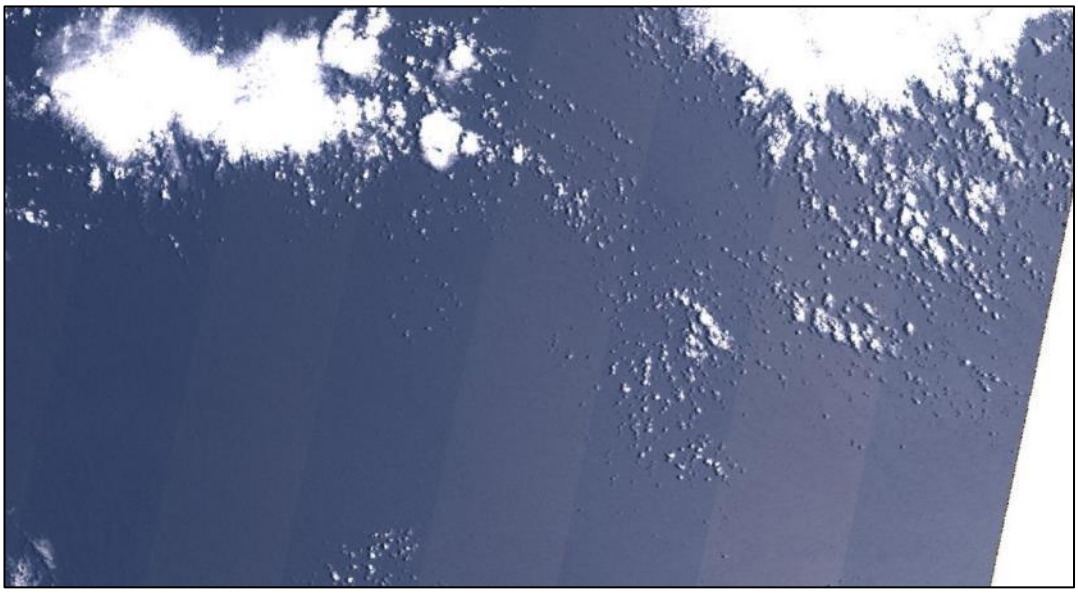
Because the viewing angles are not the same for even and odd detectors, differences in measured radiometry can be observed on non-Lambertian surfaces. This is especially visible on Sun glint over sea surfaces (see Figure below).

Figure 26: Stripe pattern over sea surface, due to the observation parallax effect between odd and even detectors.

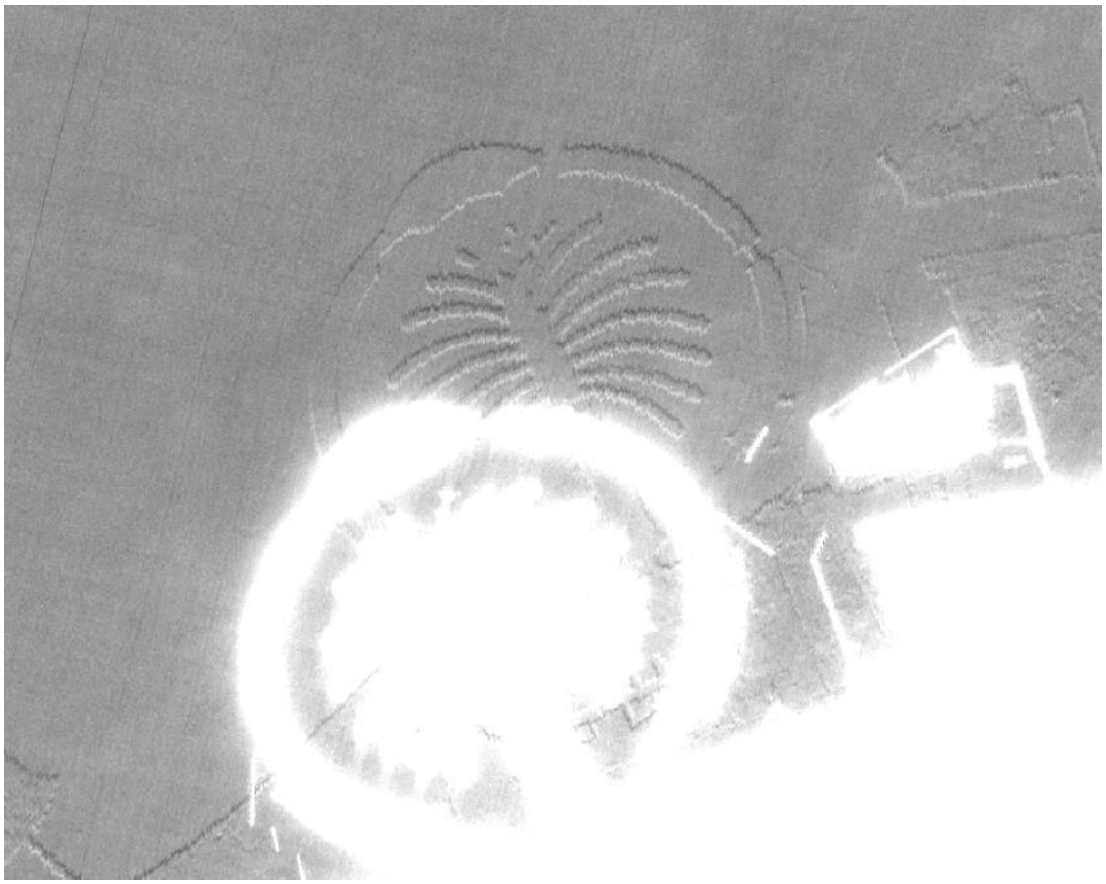
Figure 28: Gradient cross-talk on band B12 (highly enhanced contrast).

This feature can be seen on contrasted images on band B12 (typically near the coast). It can be explained by a cross-talk signal coming from the along-track gradient of the B11 image. The typical amplitude of the effect is 10 digital counts.
