SENTINEL 2

S2 MPC

Data Quality Report

Ref. S2-PDGS-MPC-DQR

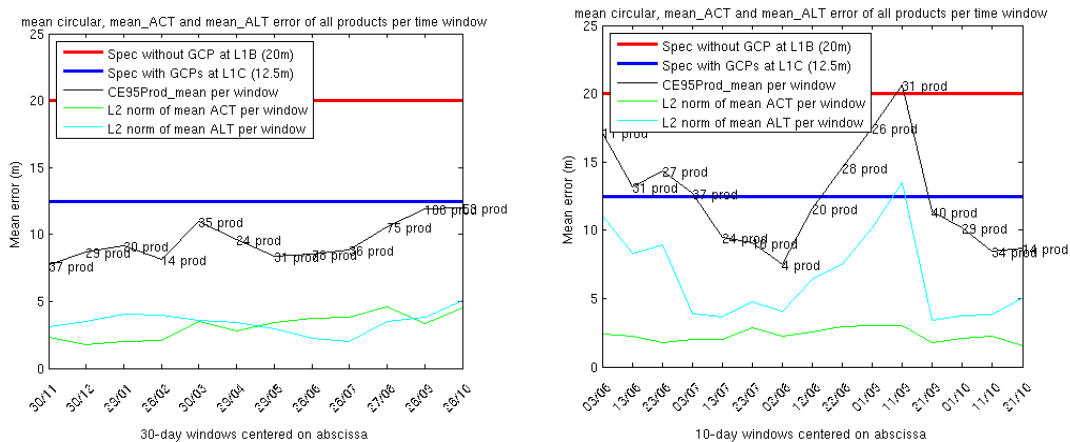
For S2A, the latest estimation (on 148 products since 15/11/2016) is better than 10.28 m at 95.5% (vs. requirement of 20 m for unrefined products), see figure below. This is compatible with the current best estimate of the long term mission performance without refining (10.5 m).

For S2B, the performance has been significantly improved after the last calibration and was measured below 10 meters at beginning of November. Note that this measurement is still based on a small number of products and needs to be consolidated in the future.

Figure 1: Geolocation performance for S2A (left) and S2B (right). The performance is computed over a sliding window of 30 (respectively 10) days for S2A (resp. S2B). The vertical dashed lines for S2B indicate the calibration updates. (ACT= across track, ALT = along track)

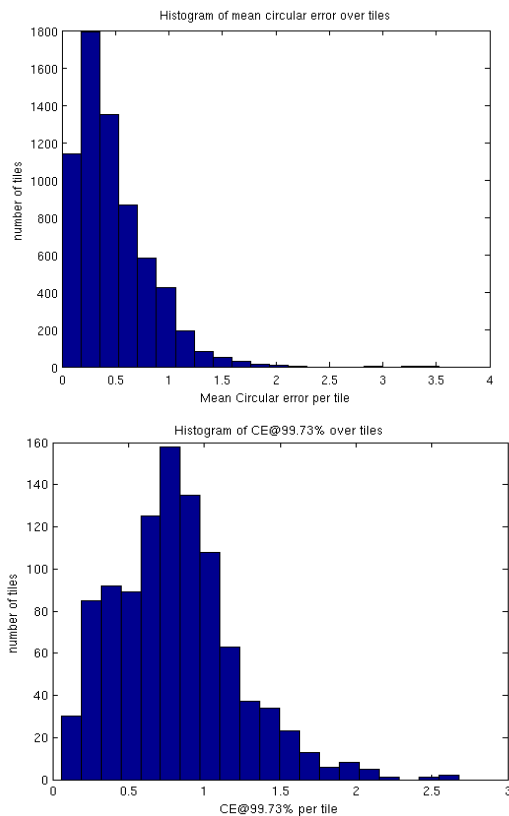
12 m. Figure 2 shows the histogram of the distribution of multi-temporal registration errors, showing a peak at 3 m. Table 3 present the observed statistical distribution of the observed multi-temporal registration performance for S2A and S2B.

Figure 2: Histogram of the multi-temporal performance for S2A (left) and S2B (right, different scale). The 3 m requirement will be applicable only after activation of the geometrical refinement. The current performance is 12 m at 95% confidence.

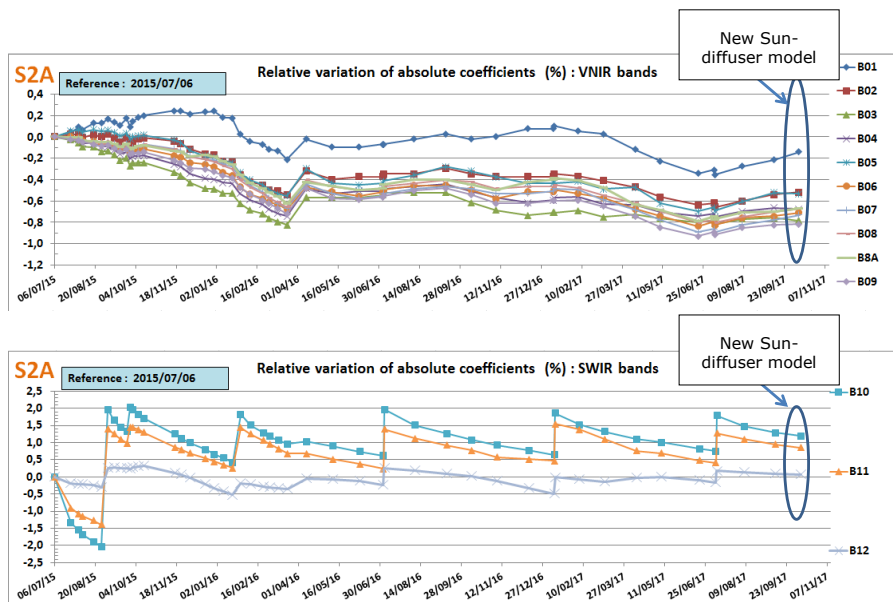
The figures below show the history of the radiometric calibration coefficients for both satellites. It can be seen that the new Sun-diffuser model does not introduce a significant jump.

Figure 3: History of the absolute calibration coefficient for S2A. The last point has been computed with the new Sun-diffuser model. Variations for SWIR bands are correlated with instrument decontaminations.

An alignment of the archive using the new Sun-diffuser model will be performed for the next reprocessing campaign (planned with the activation of the geometric refinement).

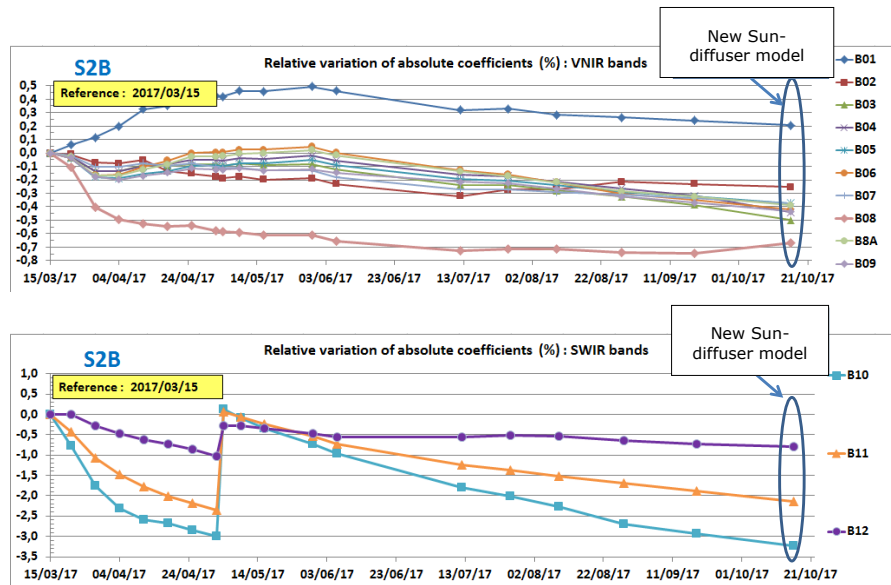
Figure 4: Same as above for S2B. Note the different time scale.

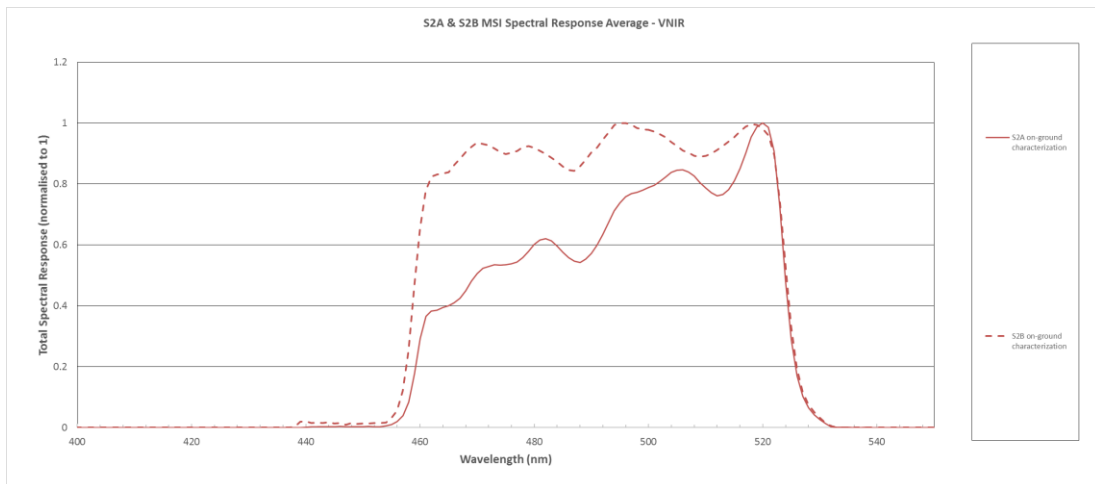
An improvement of the spectral response function characterization is currently under study. Indeed, the spectral characterization of bands B01 and B02 for S2A has been affected by a measurement defect. A correction of this defect is currently under development and will lead to an update of the reference spectral function in the coming months. In the meantime, the spectral response of S2B can be used for bands B01 and B02 of S2A as well, since the characteristics of the instruments are very comparable. The differences between the current S2A and S2B response functions (especially for Band B02, see figure 3 below) are mostly due to the above-mentioned characterization error.

Figure 5: Comparison of S2A and S2B spectral response functions for band B02. Measurements for S2A (solid curve) are affected by a defect. Users are advised to consider measurements of S2B (dashed curve) for S2A instead.

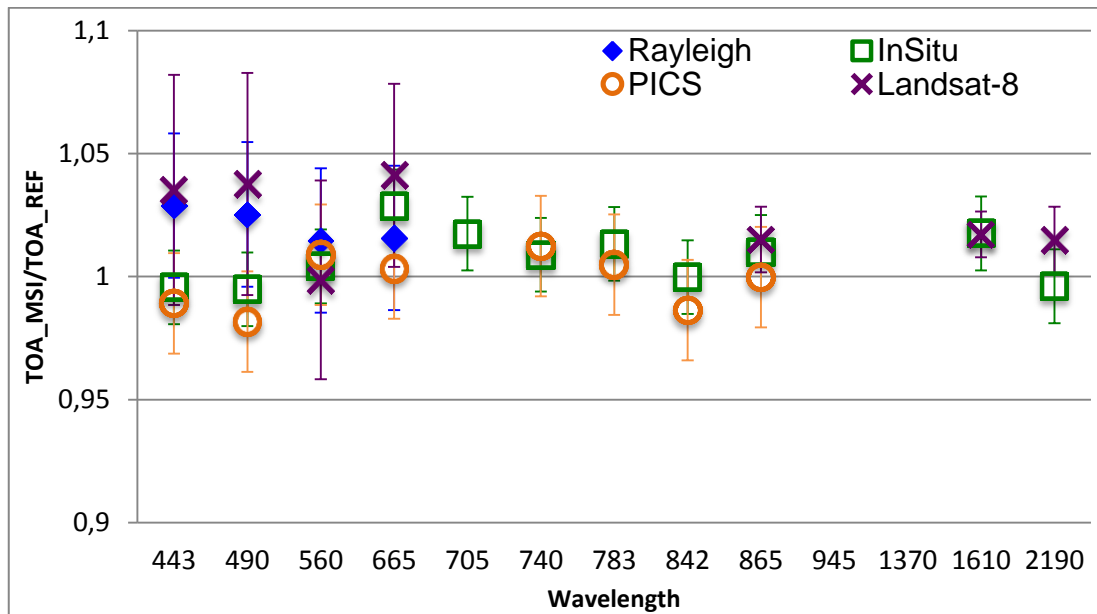
A small systematic difference in radiometry is observed between S2A and S2B: S2A is brighter (measured reflectance higher) than S2B by about 1%. This difference is currently under study.

Figure 6: Comparison of radiometric accuracy for all spectral bands (except B10): ratio of S2A measurement on reference. Error bars indicate the method uncertainty.

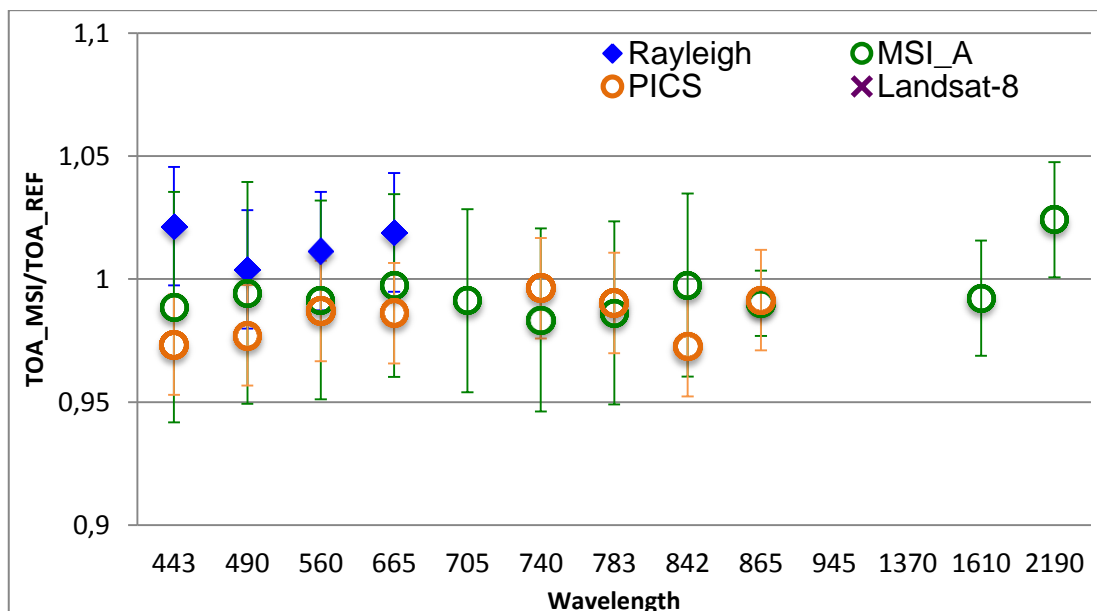
Figure 7: Comparison of radiometric accuracy for all spectral bands (except B09 & B10): ratio of S2B measurement on reference. Error bars indicate the method uncertainty.

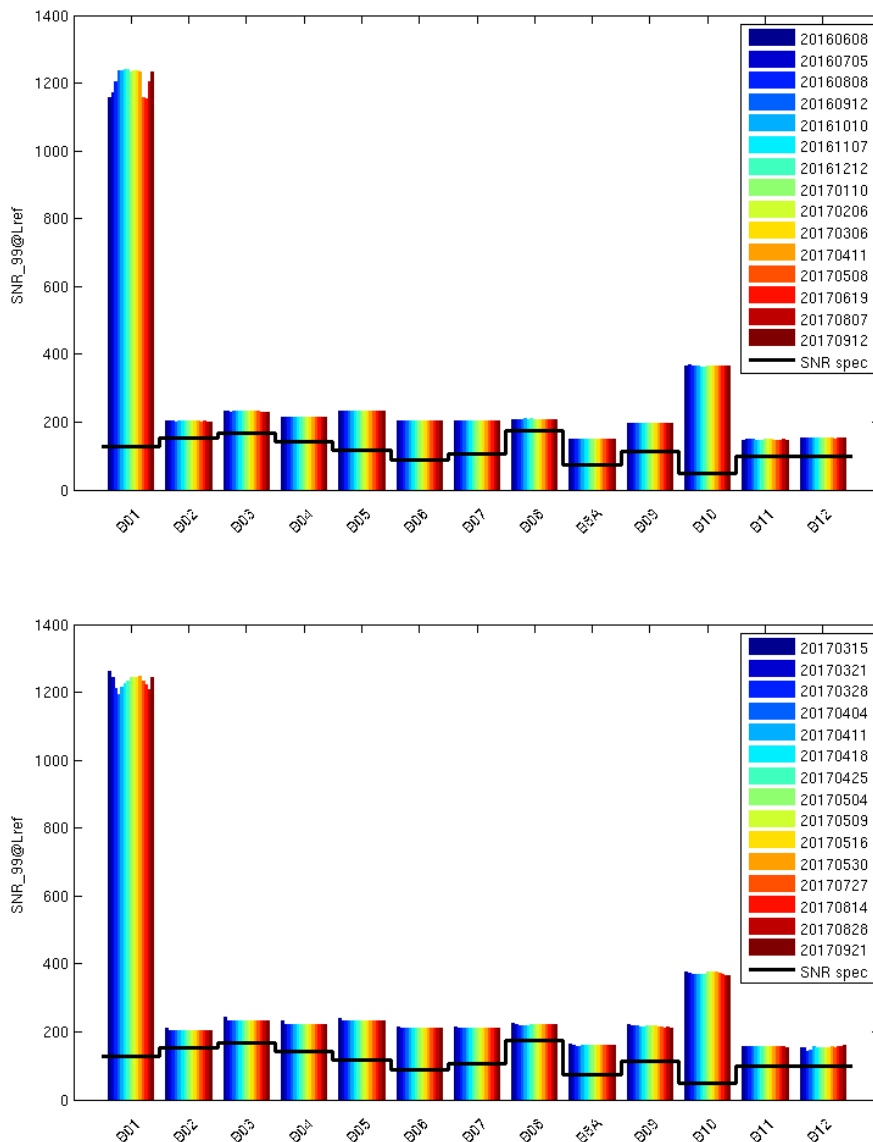
As seen in the figure below, the noise characteristics are very stable over time.

Figure 8: Evolution of the SNR performance or S2A since 08/06/2016 (top) and S2B since 15/03/2017 (bottom)

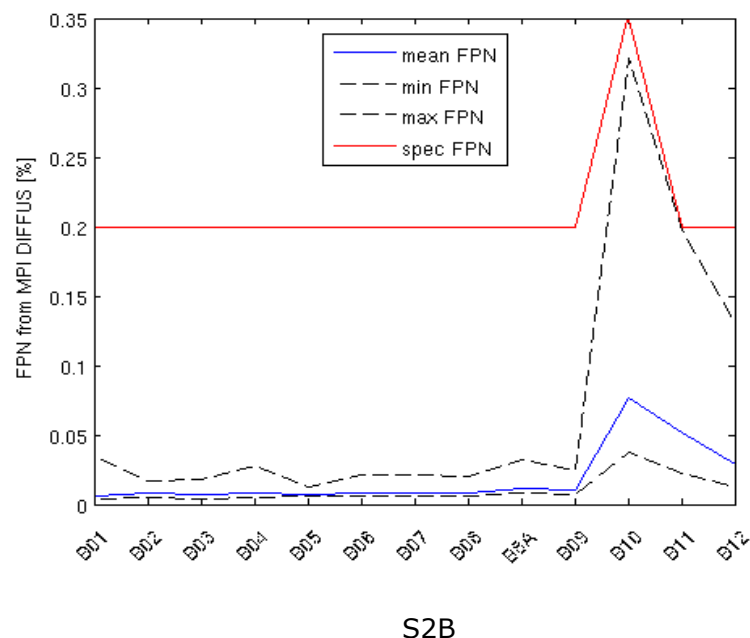
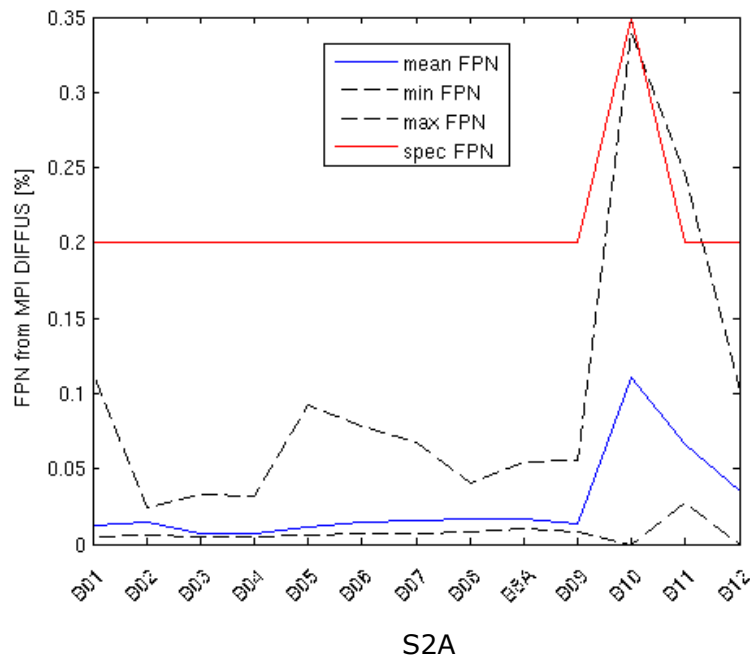
Another aspect of the image noise is the so-called Fixed Pattern Noise: this is the residual pixel radiometric error after equalization. The performance is better than the specification for all bands except for a few pixels on Bands B11 and B10.

Figure 9: Fixed Pattern Noise (residual error after equalization) measured on diffuser images for S2A (top) and S2B (bottom). Blue curve: mean FPN, red: maximum specified value. Dashed: best- and worst-case pixels.

The noise is better than requirements for VNIR bands and close to requirements for SWIR bands.

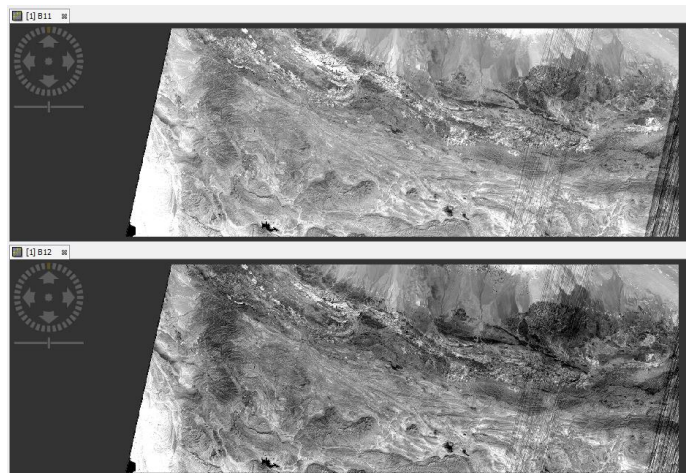
This anomaly is characterized by along-track stripes on some detectors of SWIR band images (see image below). Other detectors are also misaligned (along-track shift).

Figure 10: Striping of SWIR bands (anomaly #9). Top: B11, Bottom, B12.

This anomaly occurred during commissioning as a result of an incorrect instrument configuration. Users are advised to use only VISNIR bands for the corresponding orbits.

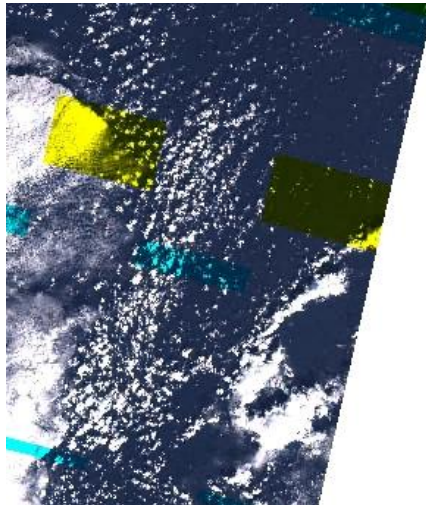
Data downlink issue sometimes lead to missing instrument source packets. This results in missing or corrupted pixels in L1C image, typically affecting only odd or even detectors and some spectral bands. The figure below presents an example of product affected by missing packets.

Figure 11: L1C product affected by a large number of missing packets. This type of feature is not considered as an anomaly and will not lead to removal of affected products.

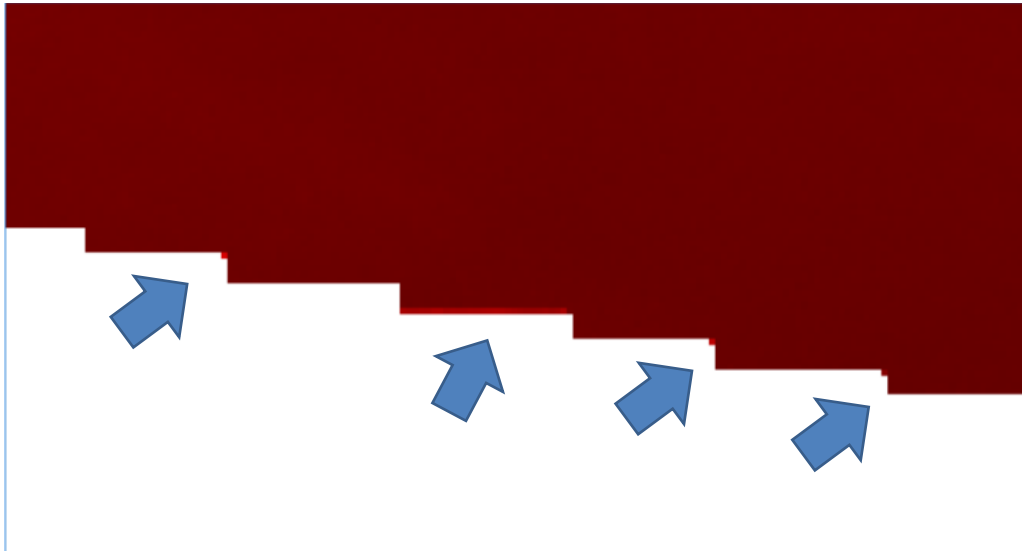
This anomaly is characterized by anomalous pixel values at the boundary of a datastrip. This anomaly has been corrected with baseline 02.02.

Figure 12: Anomalous pixels on band B4 (anomaly #12).

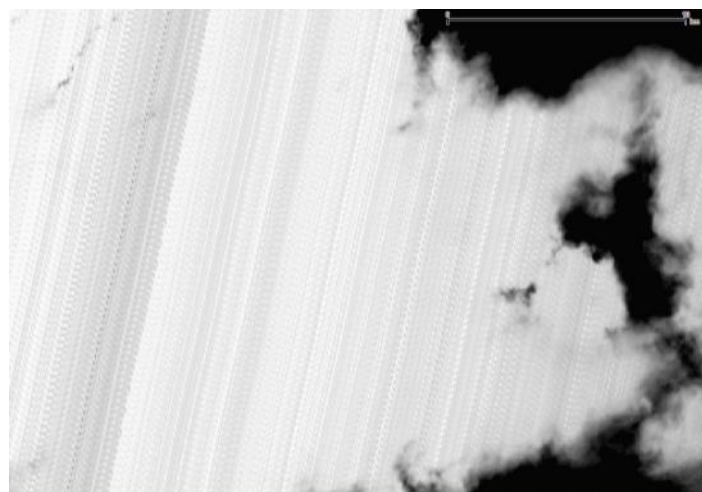
This feature is characterized by noise patterns on bright images. It has now been identified as generated by saturation of the detector. This effect is not an anomaly in itself, however the saturation is currently not correctly reported in the image quality masks. A modification of the processor is in progress to solve this issue.

Figure 13: Along-track noise pattern on B10 images over bright clouds (#13).

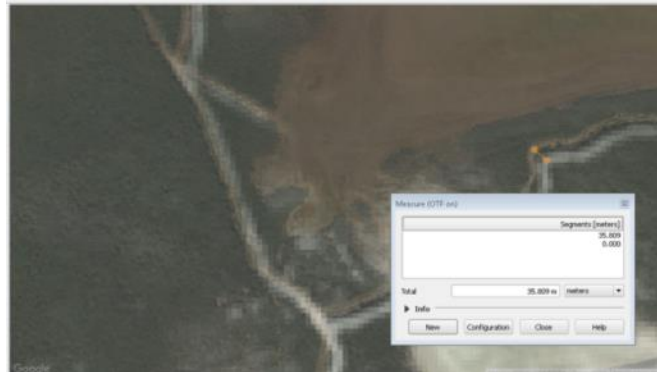
This anomaly occurred while the satellite was performing a collision avoidance manoeuvre on 16[th] August 2016. One Star Tracker was temporarily blinded by the Sun, which led to a degradation of the attitude estimation. As a result, the geolocation of the products acquired during this period (orbits 6003 to 6011) is affected by a variable geolocation error of up to 100 meters.

The anomaly seems related to the handling of the redundant Star Tracker in the attitude estimation system. Further analysis is on-going and possible remediation is investigated.

Figure 17: S2 image superimposed with reference map, showing a geolocation error of 35 m (anomaly #18).

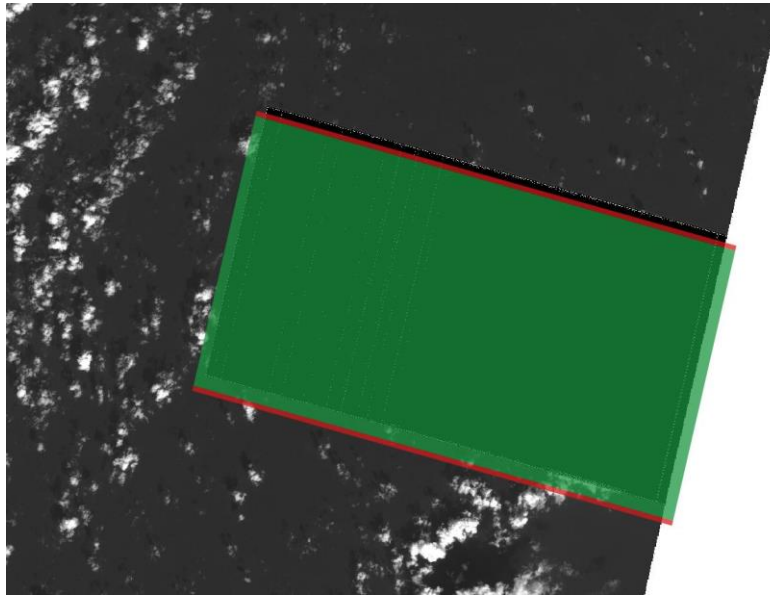
Since October 2016, technical quality masks (TECQA) are reporting instance of lost data packets (see anomaly #10). However it has been found that the masks are not perfectly accurate (see figure below). This anomaly is corrected with production baseline 02.05.

Figure 18: Technical Quality masks (green: lost packets, red: degraded packets) overlayed over an affected imaged. A small gap exists between the mask and the affected area (anomaly #21).

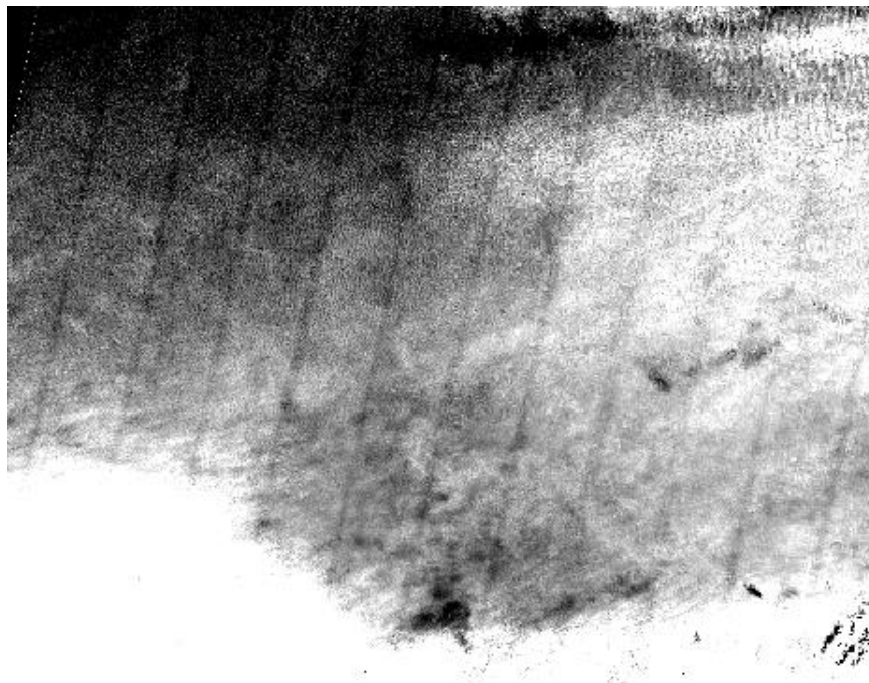
This feature is characterized by along-track soft-edged darker or brighter stripes near the detector boundaries, as shown on the figure below. Indeed, the spectral response is slightly different at the edges of the detectors, especially for bands B03 and B05. When the spectrum of the scene has strong gradient over the spectral bandwidth of the detector, a difference in the measured radiometry can be observed (up to 2% in worst-cases).

Figure 19: Along-track stripes resulting from spectral response non-uniformity (band B03).

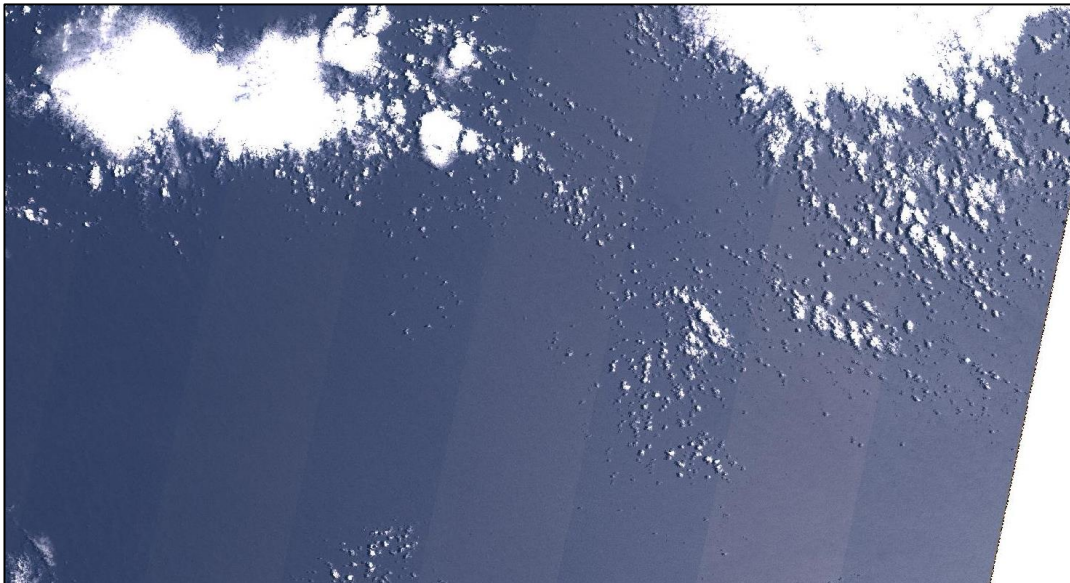
Because the viewing angles are not the same for even and odd detectors, differences in measured radiometry can be observed on non-Lambertian surfaces. This is especially visible on Sun glint over sea surfaces (see Figure below).

Figure 20: Stripe pattern over sea surface, due to the observation parallax effect between odd and even detectors.

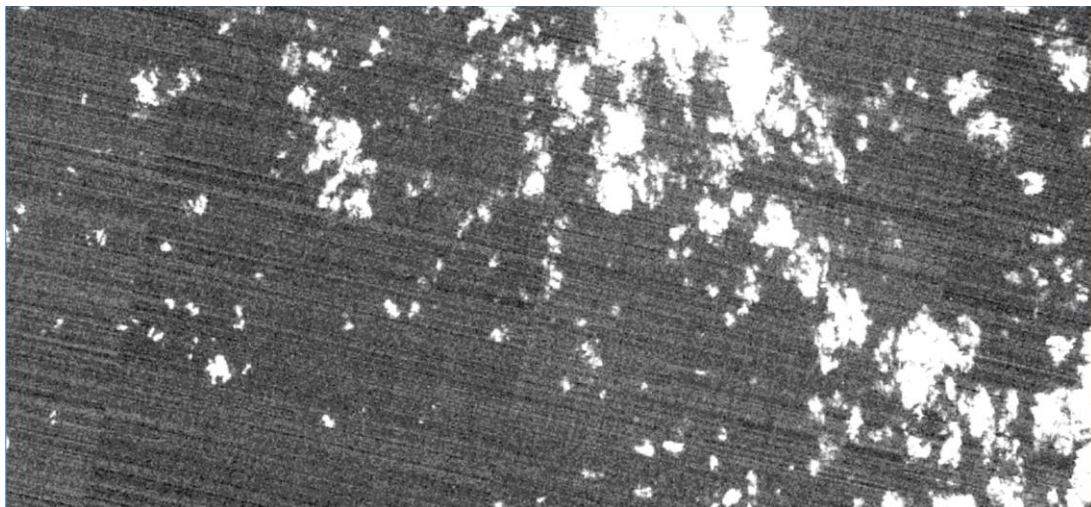
Figure 22: Across-Track intra-detector noise pattern

This feature can be observed in very dark images (typically on B10 or B12 over the sea). It is characterized by across-track lines covering a whole detector. The typical range of this noise pattern is a few digital counts, and therefore within the requirements of the mission.
