SENTINEL 2

Data Quality Report

Ref. S2-PDGS-MPC-DQR

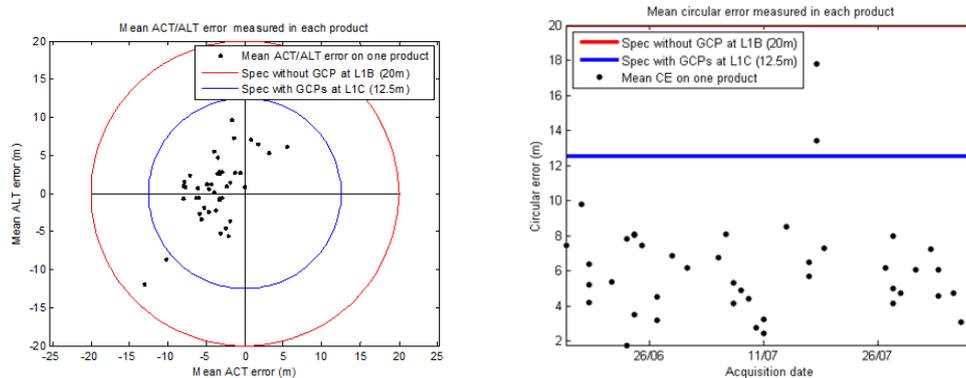
Figure 2 (left) presents the point cloud of measured errors for all products analysed (baseline 02.04). The figure shows a small negative across-track bias, which has been linked to a small drift of the roll viewing angle of the instrument. This effect will be corrected by calibration in the next period.

Figure 2 (left) also reveals the presence of two outlier measurements with an error exceeding 12.5 m (blue circle) but still within the applicable requirement (20 m, red circle). These outliers are also clearly visible on the timeline (Figure 2, right) and correspond to acquisitions on orbit 5601 (18/07/2016). Further investigations showed that the reduced performance is linked to a temporary outage of the Star Tracker. It has been decided to add an automatic quality check to track such events and report them in the product quality metadata.

Figure 2: Geolocation performance assessment with processing baseline 02.04. Left: Point cloud of measured errors in Across-Track (ACT)/Along-Track (ALT) frame. Right: Timeline of measured circular errors.

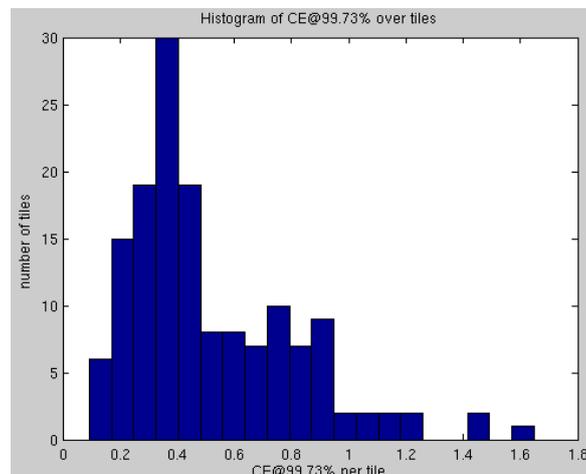
While the progress on the GRI continues, the methodology to assess multi-temporal performance has been consolidated and preliminary estimation of the performance before refinement has been obtained. The multi-temporal registration error for one tile is estimated as a worst-case (99.73% percentile) of the measured error for all control points of the tile. Then the global performance is taken as the 95.5% percentile of the value for all tiles. According to this methodology, the current performance is 1.12 pixel. Figure 3 shows the histogram of the distribution of multi-temporal registration errors, showing a peak at 0.3 pixels.

Figure 3: Histogram of the measured circular error (in pixels).

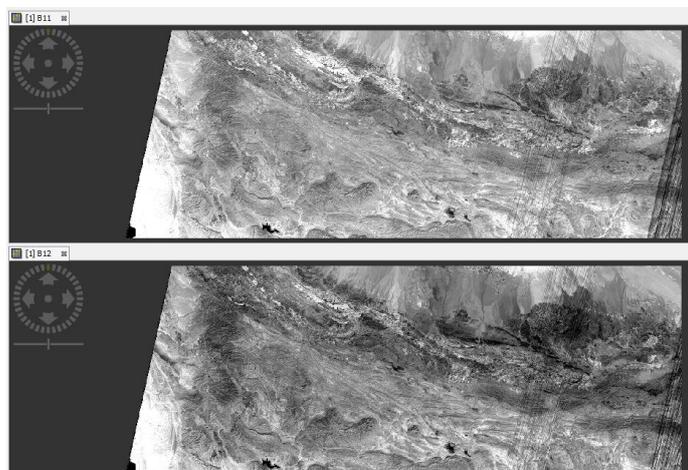
This anomaly is characterized by along-track stripes on some detectors of SWIR band images (see image below). Other detectors are also misaligned (along-track shift).

Figure 9: Striping of SWIR bands (anomaly #9). Top: B11, Bottom, B12.

This anomaly occurred during commissioning as a result of an incorrect instrument configuration. Users are advised to use only VISNIR bands for the corresponding orbits.

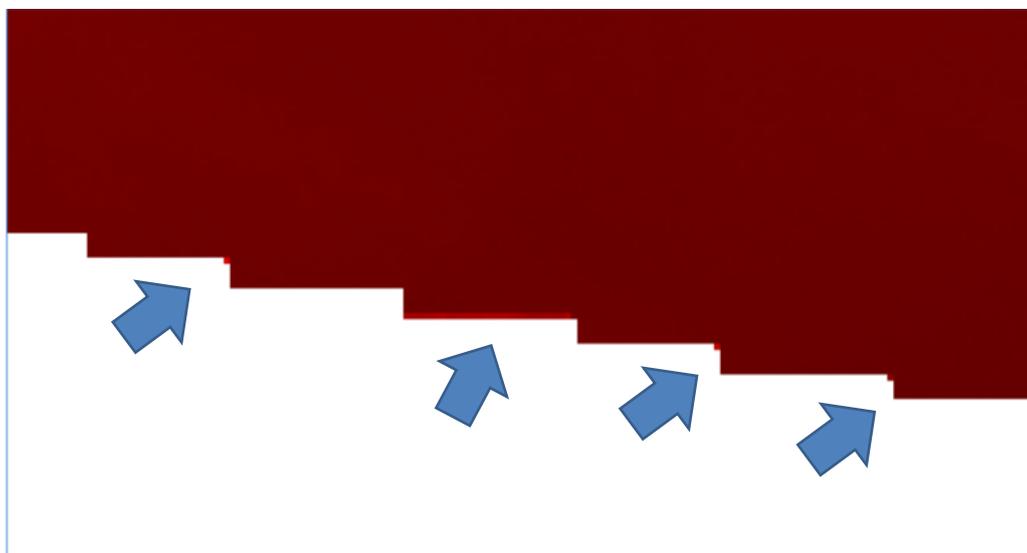
This anomaly is characterized by anomalous pixel values at the boundary of a datastrip. This anomaly has been corrected with baseline 02.02.

Figure 10: Anomalous pixels on band B4 (anomaly #12).

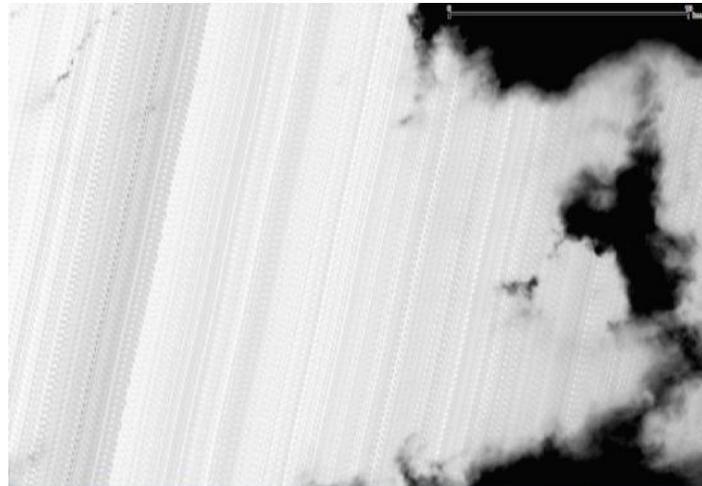
This feature is characterized by noise patterns on bright images. It has now been identified as generated by saturation of the detector. This effect is not an anomaly in itself, however the saturation is currently not correctly reported in

the image quality masks. A modification of the processor is in progress to solve this issue.

Figure 11: Along-track noise pattern on B10 images over bright clouds (#13).

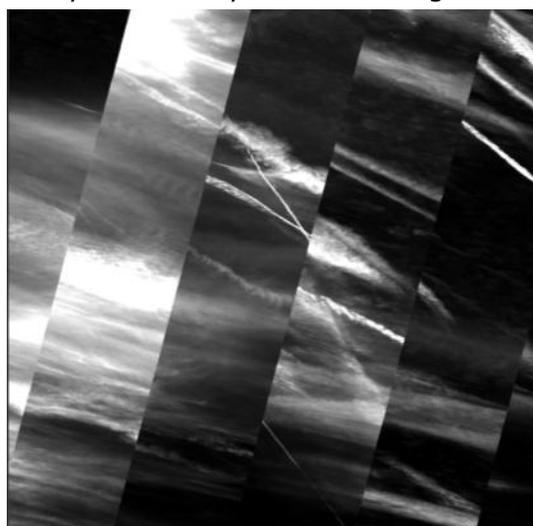
This anomaly is characterized by an incorrect appearance of the 60 m bands: images are stretched across-track and discontinuities are visible between detector boundaries. A few occurrences have been observed, and none since 27/04/2016. This anomaly is currently under investigation.

Figure 13: Stretching of 60 m bands (anomaly #16).

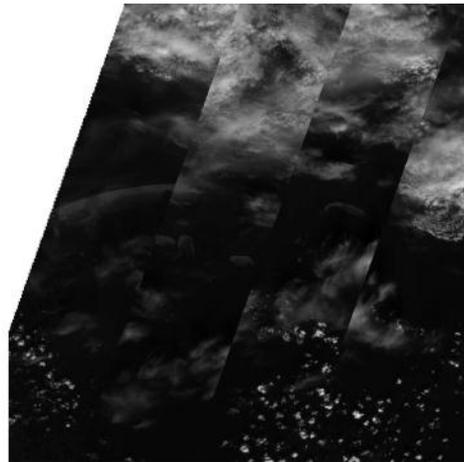
An anomaly on the receiving ground station occurred on 12th of July and led to corrupted products for a few orbits (5509 to 5525). The anomaly affects only band 1 and is limited the first products for the datastrips (Northern part). It is characterized by a misalignment of the odd and even detectors, as illustrated in the figure below.

Figure 14: Detector misalignment on band B1 (anomaly #17).

A possible correction of this anomaly by an ad-hoc reprocessing is under study.

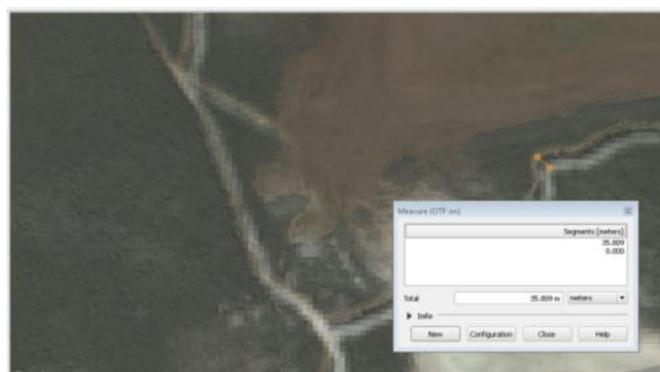
This anomaly occurred while the satellite was performing a collision avoidance manoeuvre. One Star Tracker was temporarily blinded by the Sun, which led to a degradation of the attitude estimation. As a result, the geolocation of the products acquired during this period (orbits 6003 to 6011) is affected by a variable geolocation error of up to 100 meters.

The anomaly seems related to the handling of the redundant Star Tracker in the attitude estimation system. Further analysis is on-going and possible remediation is investigated.

Figure 15: S2 image superimposed with reference map, showing a geolocation error of 35 m (anomaly #18).

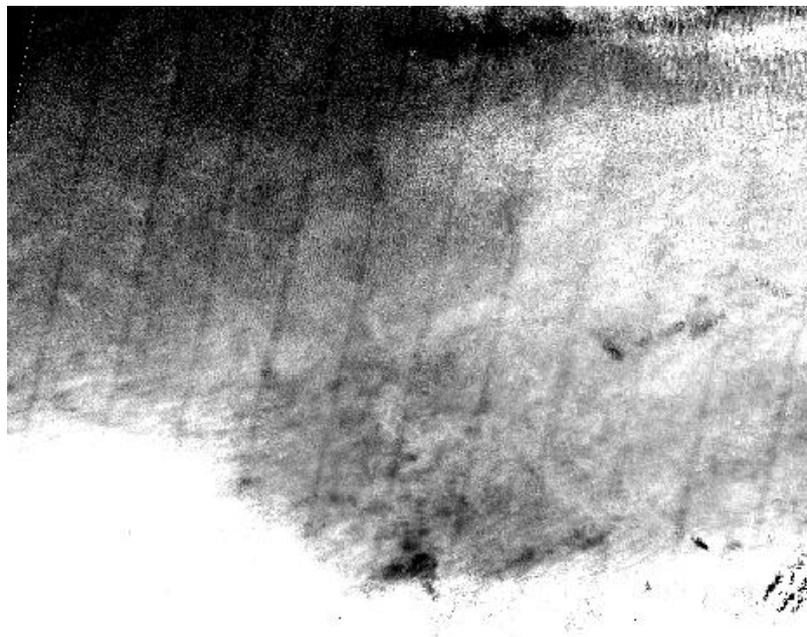
This feature is characterized by along-track soft-edged darker or brighter stripes near the detector boundaries, as shown on the figure below. Indeed, the spectral response is slightly different at the edges of the detectors, especially for bands B03 and B05. When the spectrum of the scene has strong gradient over the spectral bandwidth of the detector, a difference in the measured radiometry can be observed (up to 2% in worst-cases).

Figure 16: Along-track stripes resulting from spectral response non-uniformity (band B03).

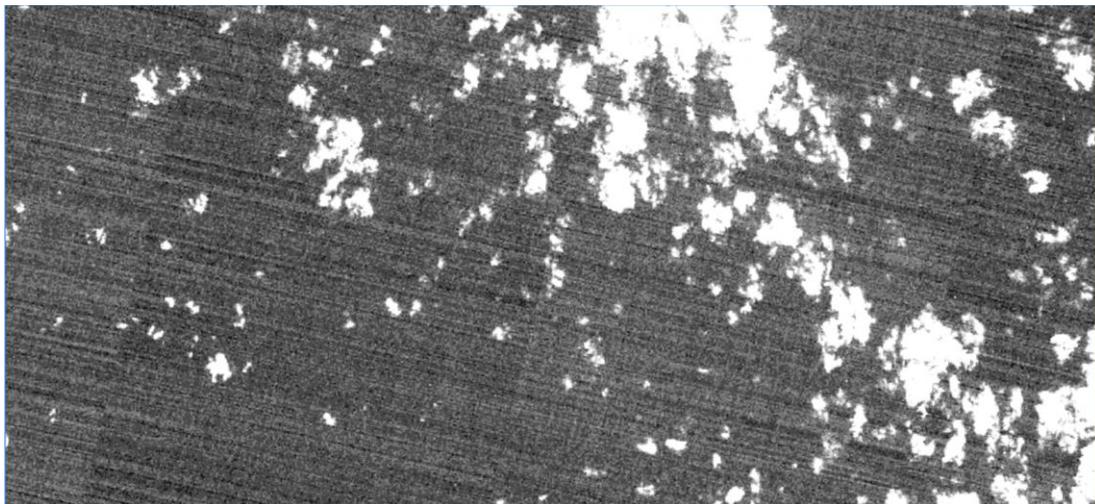
Figure 18: Across-Track intra-detector noise pattern

This feature can be observed in very dark images (typically on B10 or B12 over the sea). It is characterized by across-track lines covering a whole detector. The typical range of this noise pattern is a few digital counts, and therefore within the requirements of the mission.

This phenomenon is induced by the compression noise on "blind" pixels used for dark signal correction. A solution to filter out this noise has been identified and its operational implementation is currently under study.
