COPERNICUS SPACE COMPONENT SENTINEL OPTICAL IMAGING

Data Quality Report

Sentinel-2 L1C MSI

October 2022

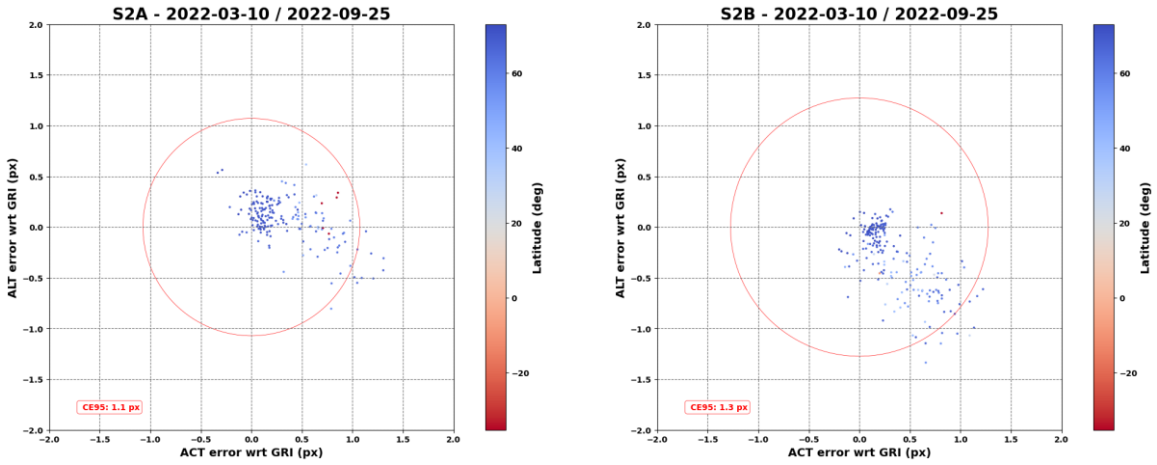
Figure 1 shows the absolute geolocation performance for the unrefined products relative to the Sentinel-2 GRI. The real absolute performance is expected to be a little worse due to the GRI absolute geolocation uncertainty (6 m). For S2A, we observed improved and stable results in the last months. For S2B, an increase of the ACT and ALT bias with regards to the GRI is observed recently.

Figure 1: Absolute geolocation performance for unrefined products. Left: S2A, Right: S2B (06.01.2022 – 24.07.2022)

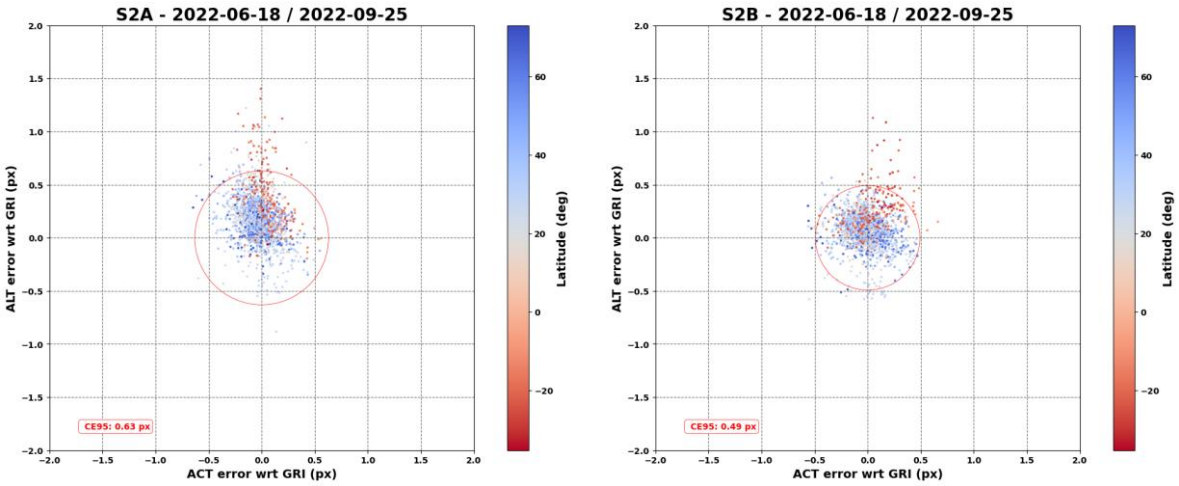
Absolute geolocation estimations for refined products relative to the Sentinel-2 GRI show a stable performance for both S2A and S2B with an absolute geolocation error better than 0.63 m for S2A and 0.49 m for S2B (at 95% confidence). Please note that, as for the unrefined products, the real absolute performance is expected to be a little worse due to the GRI absolute geolocation uncertainty (6 m).

Figure 4: Absolute geolocation performance for refined products.
Left: S2A, Right: S2B (18.06.2022 – 25.09.2022)

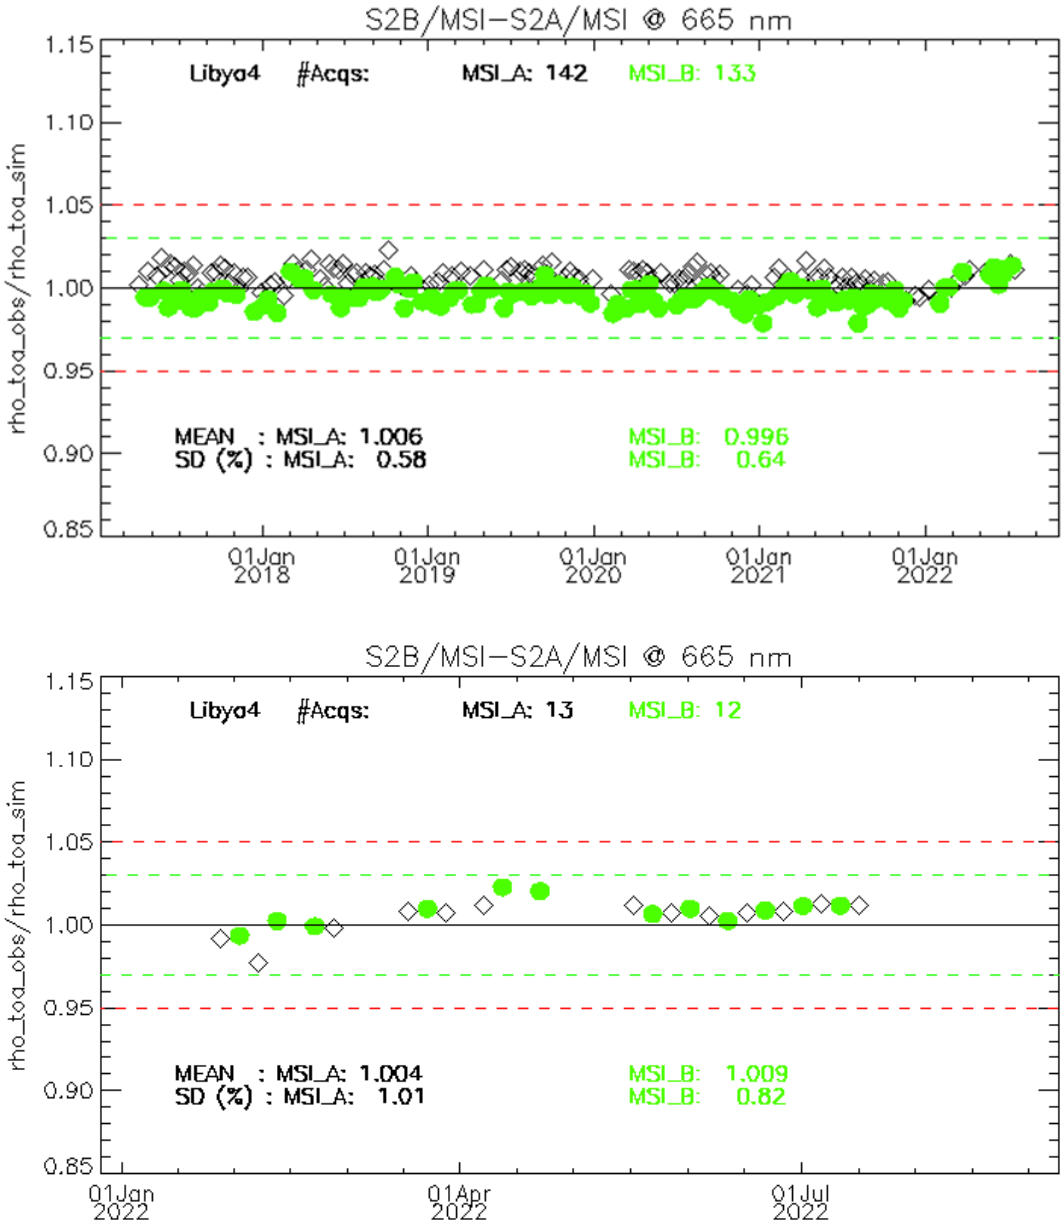
The time series below (Figure 8) shows this change in the radiometry for Sentinel-2B since the introduction of this radiometric correction factor (January 2022) and highlights the current alignment between Sentinel-2A and Sentinel-2B for Libya4 PICS Cal/Val site.

Figure 8 : Time-series of the elementary ratios (observed/simulated) signal from MSI-A (black diamonds) and MSI-B (green dots) over the period (top) up to July 2022 and (bottom) January-July 2022 for band B04 from Libya4 PICS Cal/Val site. Dashed-green and orange lines indicate the 3% and 5% error respectively.

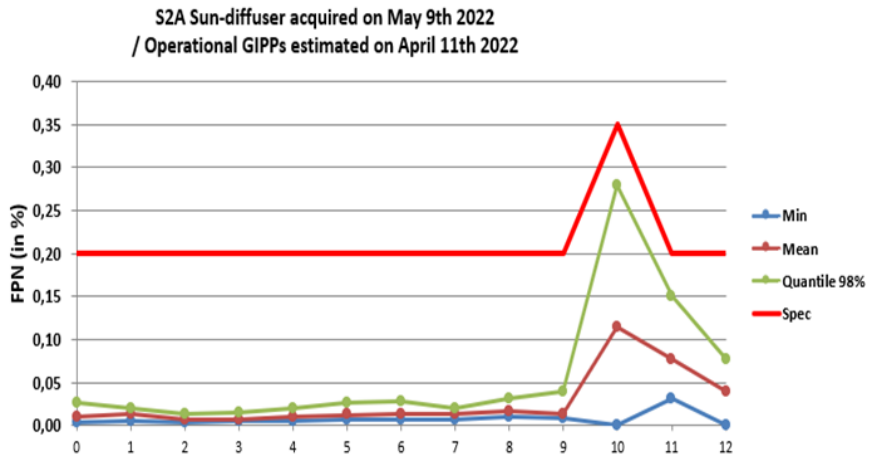
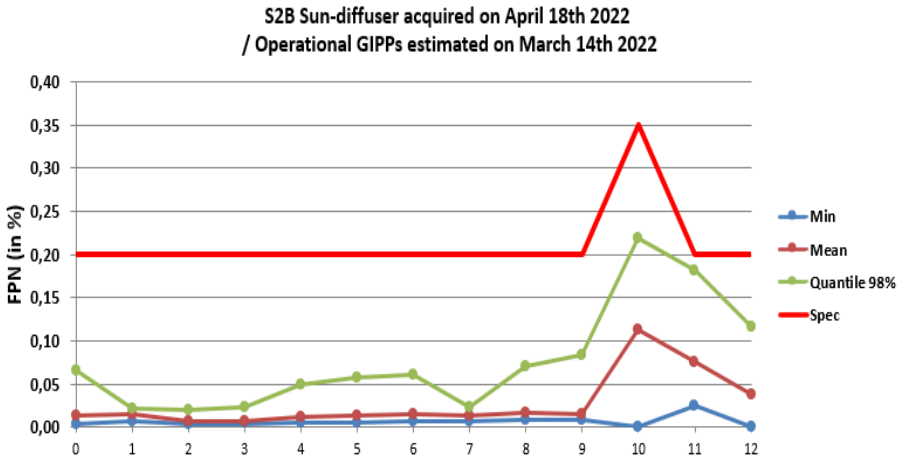
Another aspect of the image noise is the so-called Fixed Pattern Noise (FPN): this is the residual pixel radiometric error after equalization. The performance computed on diffuser acquisitions is better than the specification for all bands except for a few pixels on bands B10 and B11.

Figure 14: Fixed Pattern Noise (residual error after equalization) measured on diffuser images for S2A (top) and S2B (bottom). Blue curve: min FPN, marron: mean, green: 98 percentile, red: specified value.

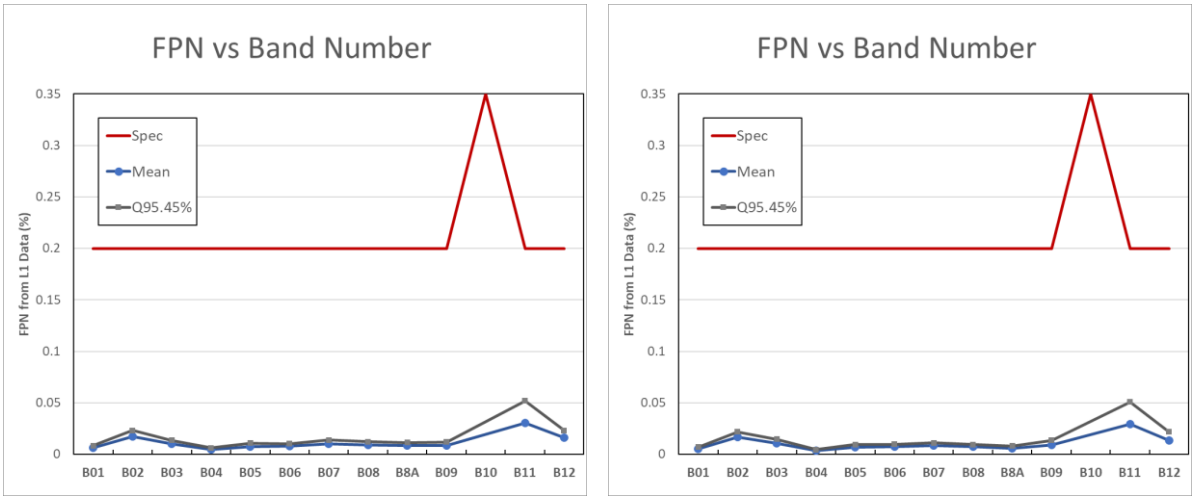
The FPN is also computed on images over radiometrically uniform natural targets like deserts or snow. A selection based on the cloud cover is performed.
As for the assessment performed over diffuser acquisitions, the performance computed is better than the specification for all bands. For the band B10 the method is not applicable as the ground is not visible.

Figure 15 : Fixed Pattern Noise (residual error after equalization) measured on homogeneous natural images for S2A (left) and S2B (right) from 08/2022. Blue curve: mean FPN, grey curve: Q95.45 percentile, red curve: specified value.

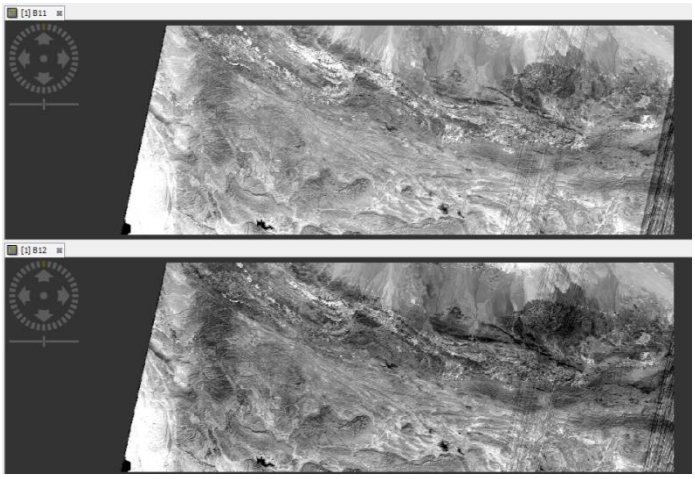
This anomaly is characterized by along-track stripes on some detectors of SWIR band images (see image below). Other detectors are also misaligned (along-track shift).

Figure 18: Striping of SWIR bands (anomaly #9). Top: B11, Bottom, B12.

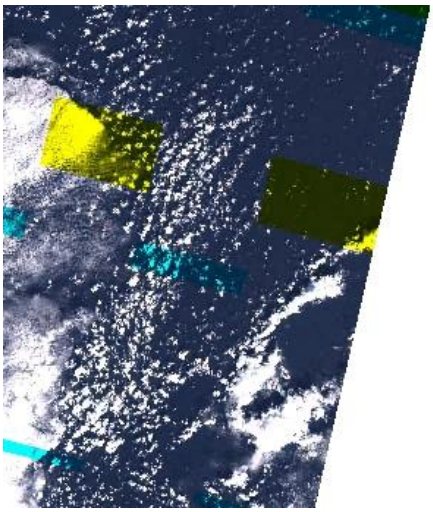
Data downlink issues sometimes lead to missing instrument source packets. This results in missing or corrupted pixels in L1C image, typically affecting only odd or even detectors and some spectral bands. The figure below presents an example of product affected by missing packets.

Figure 19: L1C product affected by a large number of missing packets.
This type of feature is not considered as an anomaly and will not lead to removal of affected products.

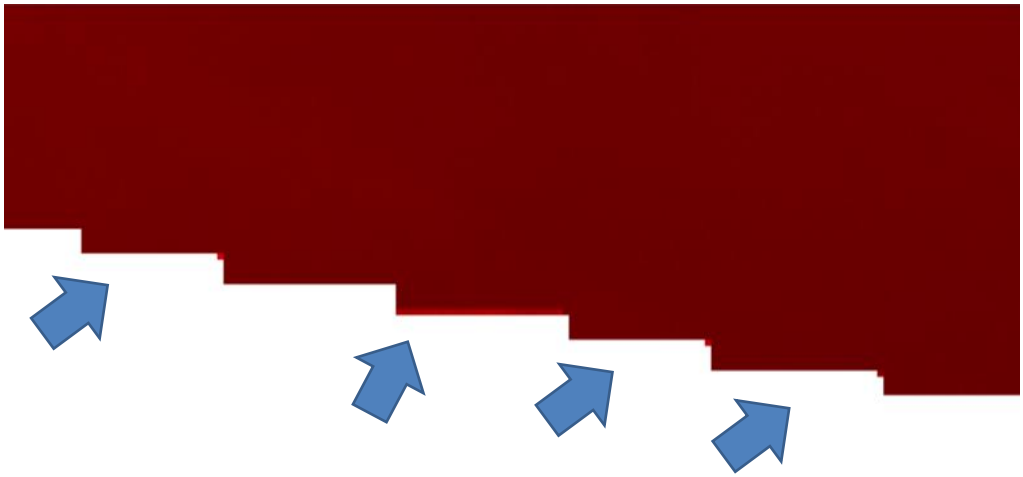
This anomaly is characterized by anomalous pixel values at the boundary of a datastrip. This anomaly has been corrected with baseline 02.02.

Figure 20: Anomalous pixels on band B4 (anomaly #12).

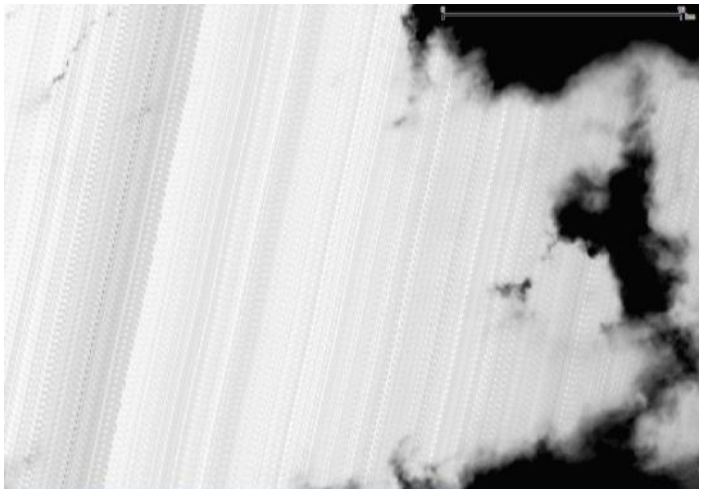
This feature is characterized by noise patterns on bright images. It has now been identified as generated by saturation of the detector. This effect is not an anomaly in itself, however the saturation is currently not correctly reported in the image quality masks. A modification of the processor is in progress to solve this issue.

Figure 21: Along-track noise pattern on B10 images over bright clouds (#13).

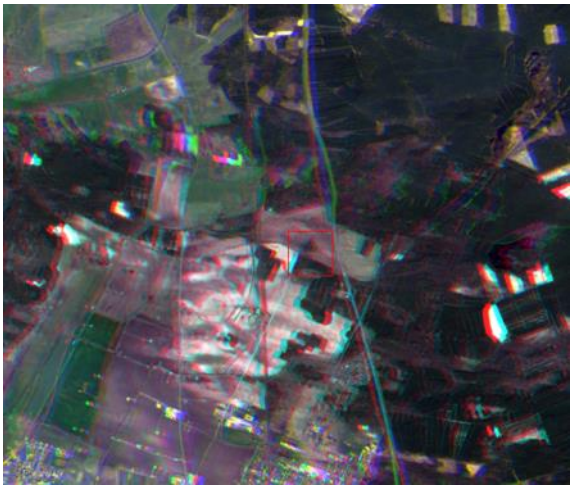
anomaly has been correctly identified by the automatic on-line quality control and the degraded geometric performance is reported in the product metadata (geometric quality check status is “FAILED”). After identification of the anomaly, the defective products have been removed from the public archive.

Figure 22: Spectral co-registration error (anomaly #14).

The root cause of this anomaly has been identified. Missing data from attitude control telemetry is at the origin of the anomaly. An optimization of the management of the on-board telemetry has been implemented since and should avoid any re-occurrence.

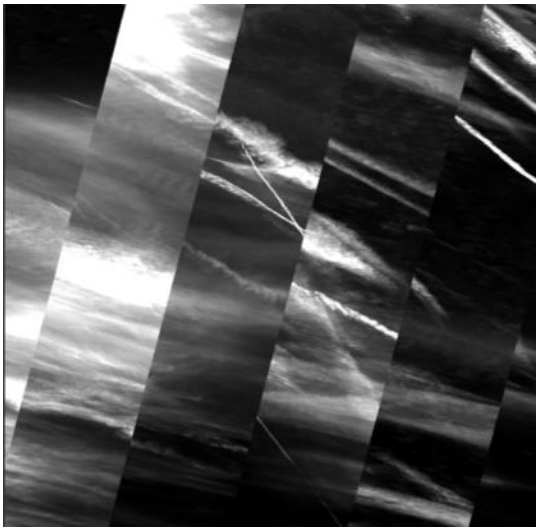
This anomaly is characterized by an incorrect appearance of the 60 m bands: images are stretched across-track and discontinuities are visible between detector boundaries. A few occurrences have been observed, and none since 27/04/2016.

Figure 23: Stretching of 60 m bands (anomaly #16).

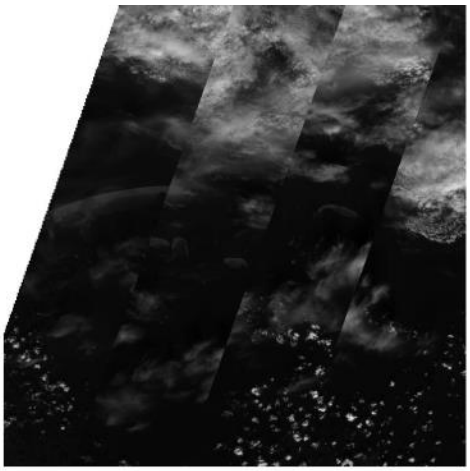
An anomaly on the receiving ground station occurred on 12th of July 2016 and led to corrupted products for a few orbits (5509 to 5525). The anomaly affects only band 1 and is limited to the first products of the datastrips (Northern part). It is characterized by a misalignment of the odd and even detectors, as illustrated in the figure below.

Figure 24: Detector misalignment on band B1 (anomaly #17).

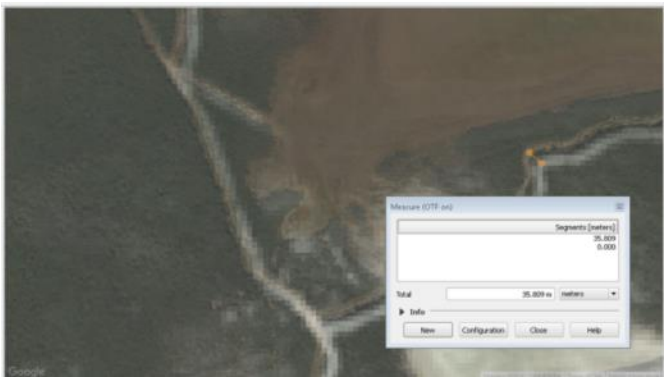
This anomaly occurred while the satellite was performing a collision avoidance manoeuvre on 16th August 2016. One Star Tracker was temporarily blinded by the Sun, which led to a degradation of the attitude estimation. As a result, the geolocation of the products acquired during this period (orbits 6003 to 6011) is affected by a variable geolocation error of up to 100 meters.

Figure 25: S2 image superimposed with reference map, showing a geolocation error of 35 m (anomaly #18).

The anomaly is related to the handling of the redundant Star Tracker in the attitude estimation system. A realignment of the Star Trackers has been performed on 20/05/2019 to prevent any new occurrence.

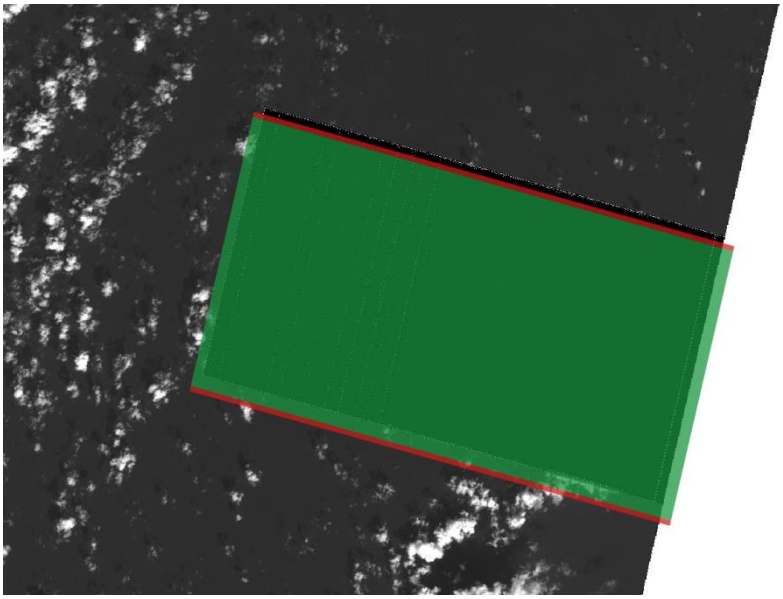
Since October 2016, technical quality masks (TECQUA) are reporting instance of lost data packets (see anomaly #10). However, it has been found that the masks are not perfectly accurate (see figure below). This anomaly is essentially corrected with production baseline 02.05. Some residual errors have been observed, which led to a further improvement deployed the 07/06/2018. A final fix has been implemented with PB 03.00 (30/03/2021).

Figure 26: Technical Quality masks (green: lost packets, red: degraded packets) overlayed over an affected image. A small gap exists between the mask and the affected area (anomaly #24).

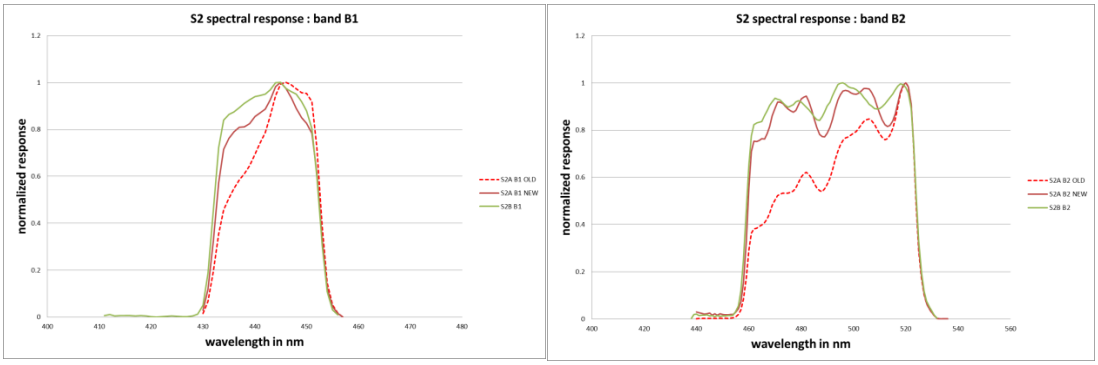
Note that this issue has negligible impact on the radiometry of the L1C reflectance products. On the other hand, the conversion to radiance values and the computation of downstream products relying on the spectral response function can be impacted (such as L2A products).

Figure 27: Spectral Response Functions for bands B01 and B02.
Red – dashed: S2A before correction. Red – solid: S2A after correction. Green: S2B.

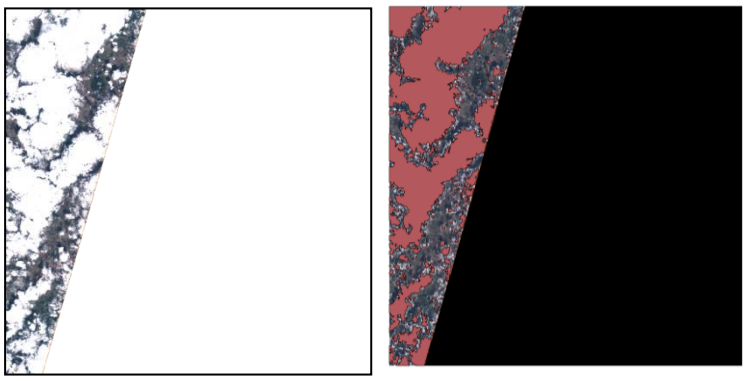
On the other hand, the cloud mask itself is correct.

Figure 28: Tile 40UGE acquired on 12/06/2018 by S2B. Left: RGB composite, Right: cloud mask (in red). The cloud coverage percentage is incorrectly reported as 19.3% (anomaly #44).

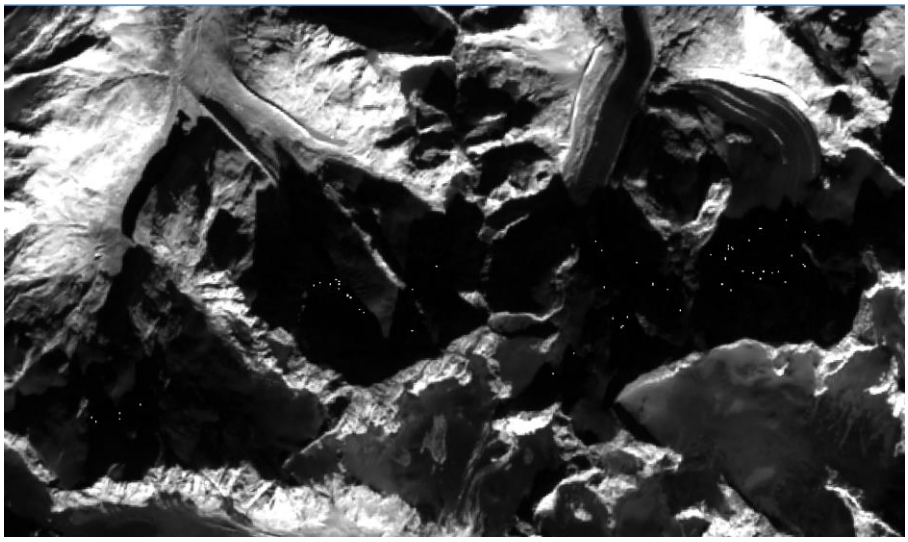
Until product baseline 02.01, several products had valid pixels with a reflectance value of 0 (No Data) instead of 1 (minimal reflectance). This anomaly was essentially fixed with baseline 02.01. However, errors induced by compression noise can still be found on very dark areas (e.g. over topographic shadows or water on SWIR bands).

Figure 29: Pixels with 0 value (No Data) shown here as transparent, in a dark area of a B12 image (Anomaly #5).

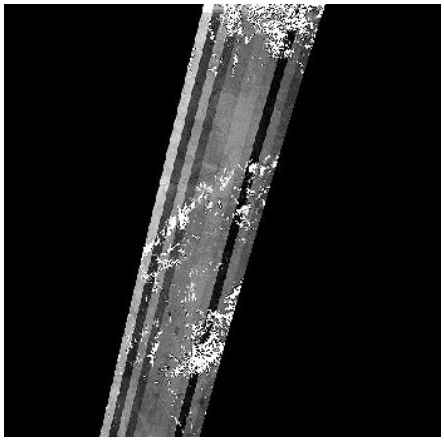
Since 18/07/2018, equalization issues have been observed on S2A products. The issue is especially visible on Band 10 if the contrast is enhanced. This issue also affects the cirrus cloud mask which may exhibit discrepancies between detectors. Note that the impact on the radiometry is limited to a few percent. The anomaly has been corrected on 30/07/2018.

Figure 30: Incorrect equalization of B10 for S2A (anomaly #45).

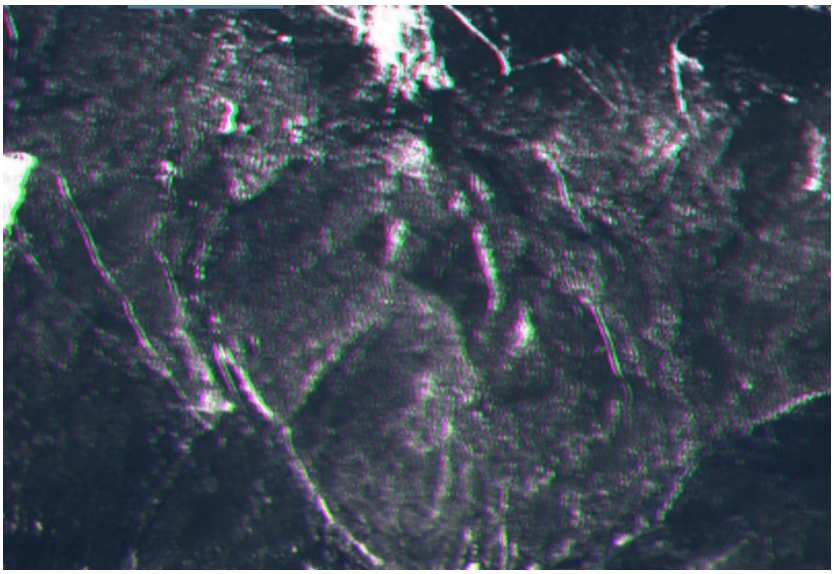
This anomaly occurred during 05/02/2019 and 12/02/2019. Some S2A products were affected by a variable spectral misregistration (up to 2 pixels). This anomaly has been fixed and the affected products have been reprocessed.

Figure 32: Spectral misregistration (anomaly #49). Affected S2A products (between 04/02/2019 and 14/02/2019) have been removed from the archive and reprocessed.

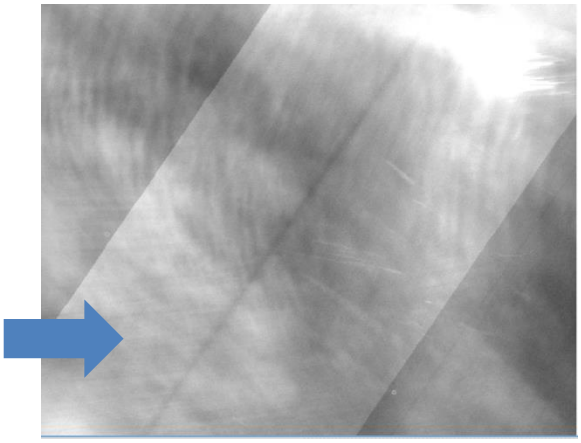
In addition to the defective pixels listed above, a group of pixels (570 to 600) of Band 11 D11 are affected by a non-linear radiometric response. This effect generates a darker along-track area in dark B11 images (e.g. on snow, see figure below).

Figure 33: Along-track stripe on B11 image due to a non-linear response on D11 (contrast strongly enhanced).

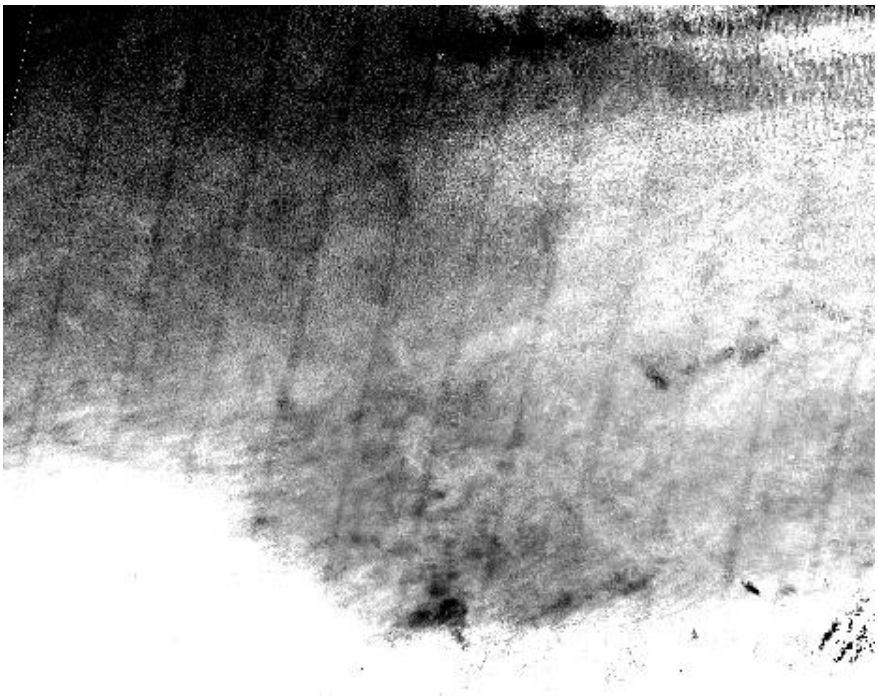
This feature is characterized by along-track soft-edged darker or brighter stripes near the detector boundaries, as shown on the figure below. Indeed, the spectral response is slightly different at the edges of the detectors, especially for bands B03 and B05. When the spectrum of the scene has strong gradient over the spectral bandwidth of the detector, a difference in the measured radiometry can be observed (up to 2% in worst-cases).

Figure 34: Along-track stripes resulting from spectral response non-uniformity (band B03).

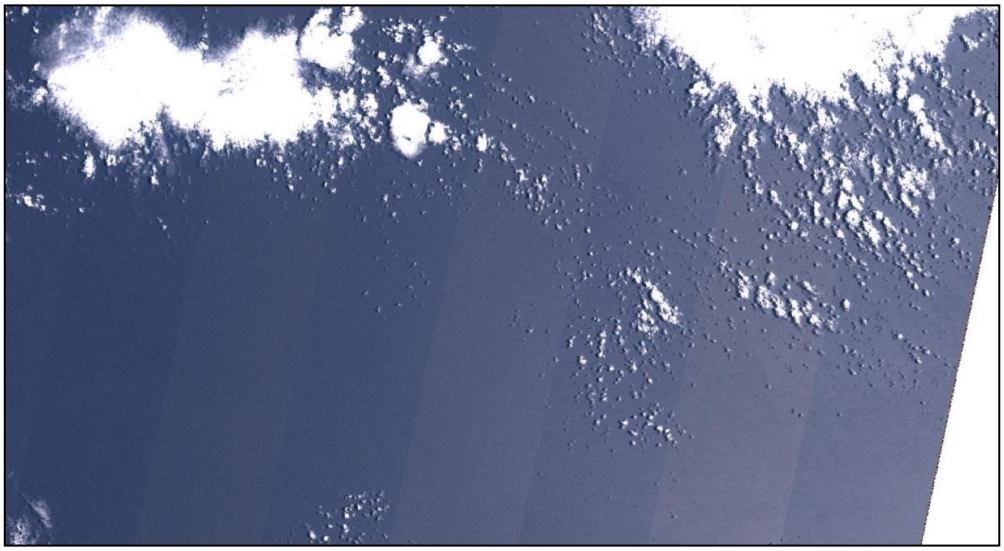
Because the viewing angles are not the same for even and odd detectors, differences in measured radiometry can be observed on non-Lambertian surfaces. This is especially visible on Sun glint over sea surfaces (see Figure below).

Figure 35: Stripe pattern over sea surface due to the observation parallax effect between odd and even detectors.

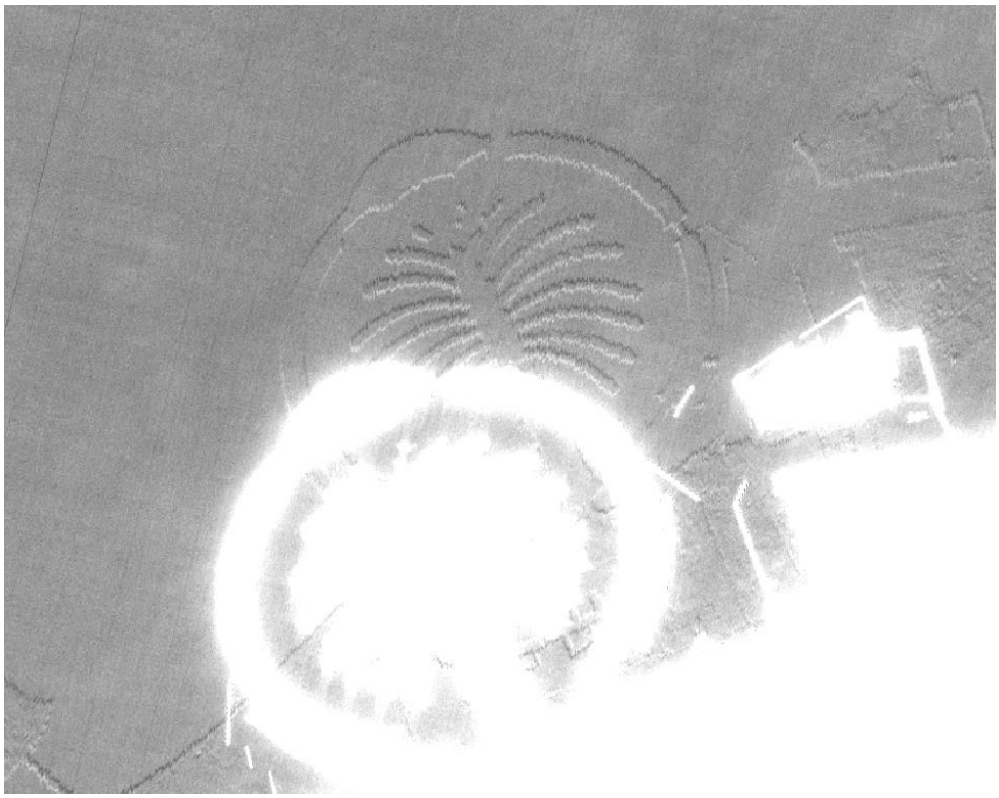
Figure 37: Gradient cross-talk on band B12 (highly enhanced contrast).
