S2 MPC

Data Quality Report

Ref. S2-PDGS-MPC-DQR

This document provides the status of Sentinel-2 mission products data quality.

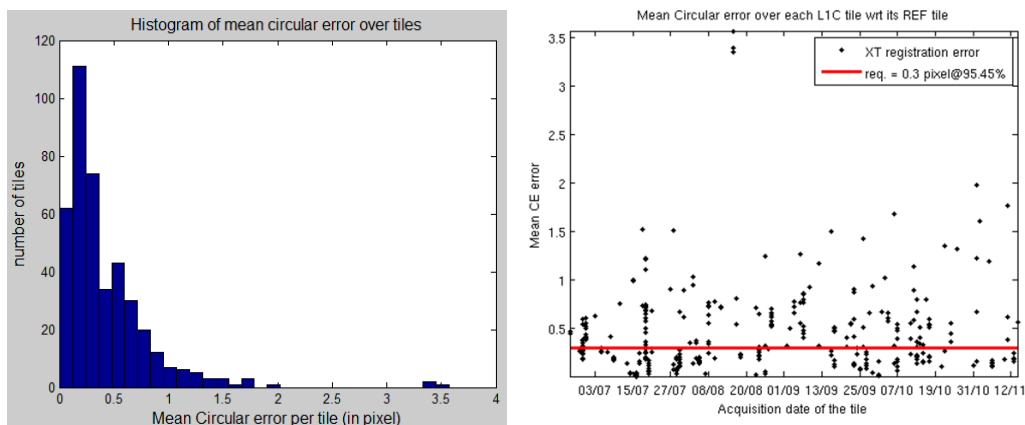
Figure 2: Histogram (left) and Time series (right) of the multi-temporal performance. The 0.3 pixel requirement will be applicable only after activation of the geometrical refinement. The current performance is 1.2 pixel at 95% confidence.

The multi-temporal registration error for one tile is estimated as the mean measured error for all control points of the tile. Then the global performance is taken as the 95.5% percentile of the value for all tiles. According to this methodology, the current performance is 1.2 pixel. Figure 3 shows the histogram of the distribution of multi-temporal registration errors, showing a peak at 0.3 pixels.

It is recalled that the objective is to meet the required 0.3 pixel performance (95.5% confidence level) with the activation of the geometric refinement using the GRI.

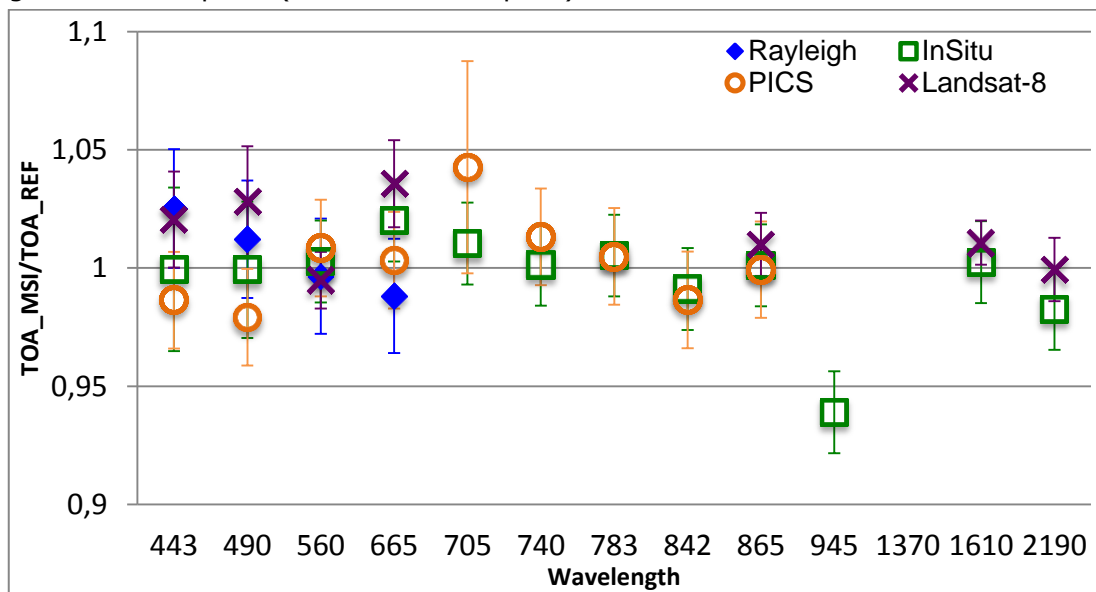
Figure 3: Comparison of radiometric accuracy for all spectral bands (except B10): ratio of S2A measurement on reference. Error bars indicate the method uncertainty.

The first two methods indicate a radiometry slightly above the reference (typically 2.5%) for visible bands but still within requirements.

The results of the different methods are presented in the figure below. Results are provided for all bands, except B10 (water vapour absorption band) for which direct validation is not possible. All results are compatible with the 5% radiometric accuracy requirement. Results for band B05 and B09 (705 and 945 nm in the figure below) are less reliable because of the significant impact of gaseous absorption (O₂ and water vapour).

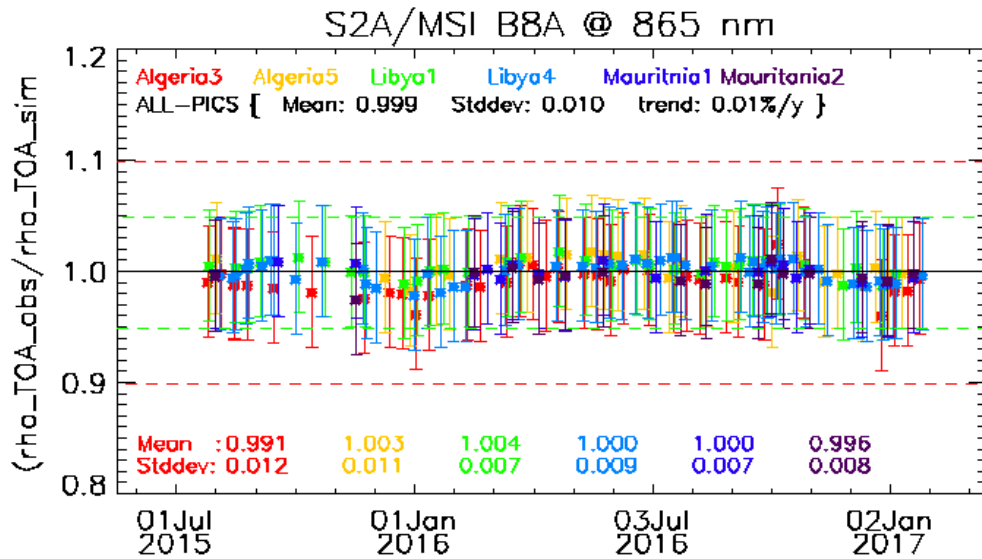
Figure 4: Time series of the ratio as observed reflectance over simulated from S2A/MSI for band B04 (665 nm, top) and band B08 (865 nm, bottom) over the 6 PICS Cal/Val-sites. Error bars indicate the method uncertainty.

Time series of measurements are also produced to monitor the evolution in time of the radiometric response, in particular to detect a possible degradation of the diffuser. The current assessment is compatible with the specified stability requirement for all visible and NIR bands (< 1% per year).

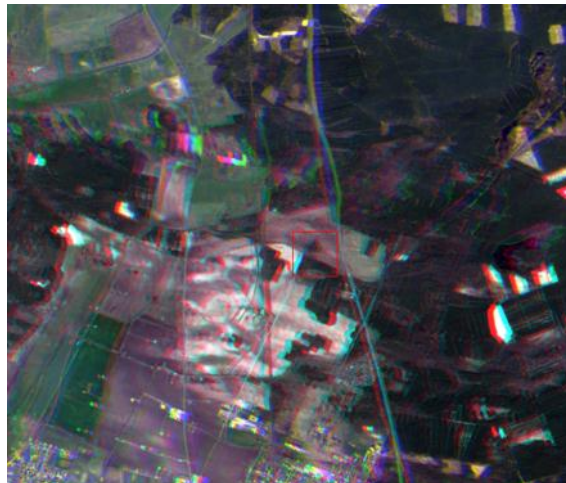
Figure 12: Spectral co-registration error (anomaly #14).

A major anomaly has led to a strong and temporary geolocation and spectral registration errors. The anomaly occurred on February 3rd (orbit 3218) and April 3rd (orbits 4080, 4081 and 4082). This anomaly has been correctly identified by the automatic on-line quality control and the degraded geometric performance is

The root cause of this anomaly has been identified. Missing data from attitude control telemetry is at the origin of the anomaly. An optimization of the management of the on-board telemetry has been implemented since and should avoid any re-occurrence.

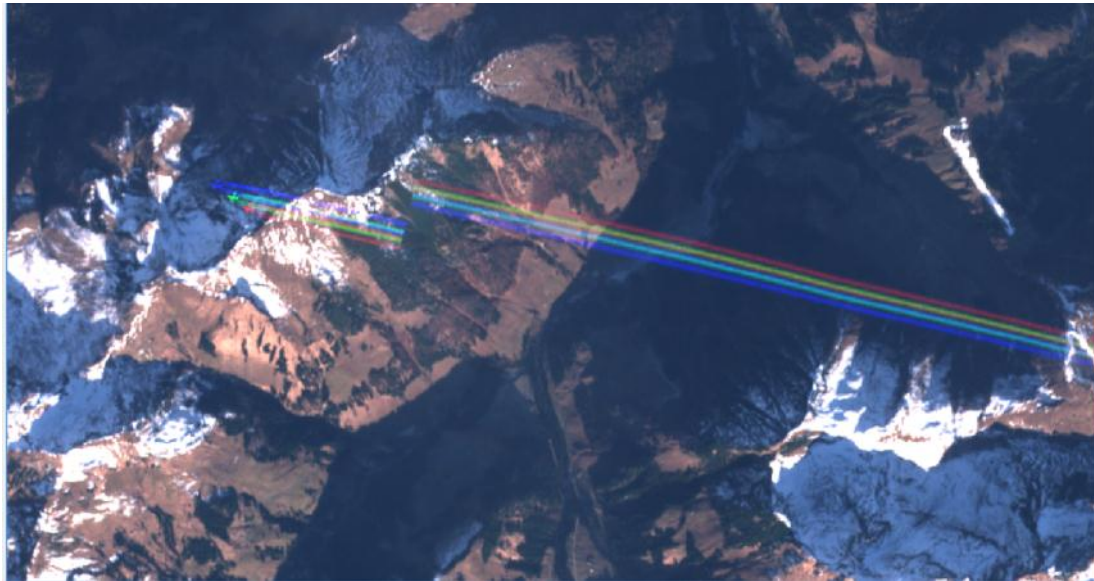
Figure 19: Spectral misregistration and detector misalignment for object at high altitude (plane and contrail). This feature is not an anomaly.

The processing algorithm ensures the coregistration of images acquired by all spectral bands and the detectors for features at ground level. Objects at a higher altitude like planes and clouds cannot be properly coregistered. As already reported in the first issue of the Data Quality Report, this effect leads to spectral misregistration ("rainbow" effect) and discontinuities between detectors.

Both effects can be seen in Figure 19 below.
