S2 MPC

Data Quality Report

Ref. S2-PDGS-MPC-DQR

This document provides the status of Sentinel-2 mission products data quality.

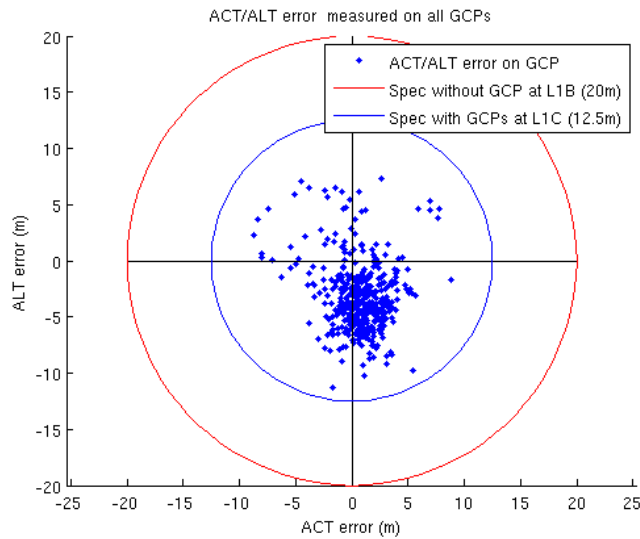
The geolocation performance is constantly monitored. The latest estimation (on 44 products since 15/11/2016) is better than 8.4 at 95.5% (vs. requirement of 20 m for unrefined products), see figure below. This is compatible with the current best estimate of the long term mission performance without refining (11 m).

Figure 1: Geolocation performance measured on 68 products since 15/11/2106 (for all Ground Control Points in Across-Track/Along-Track frame).

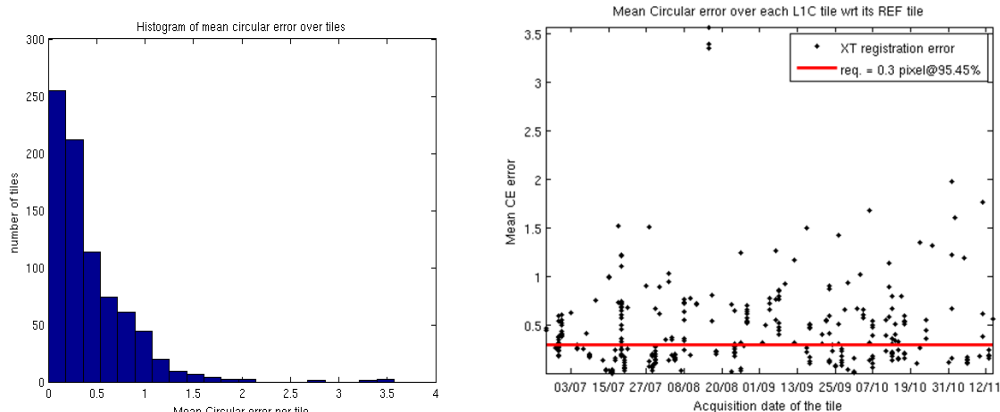
The multi-temporal registration error for one tile is estimated as the mean measured error for all control points of the tile. Then the global performance is taken as the 95.5% percentile of the value for all tiles. According to this methodology, the current performance is 1.2 pixel. Figure 3 shows the histogram of the distribution of multi-temporal registration errors, showing a peak at 0.3 pixels.

Figure 2: Histogram (left) and Time series (right) of the multi-temporal performance. The 0.3 pixel requirement will be applicable only after activation of the geometrical refinement. The current performance is 1.2 pixel at 95% confidence.

It is recalled that the objective is to meet the required 0.3 pixel performance (95.5% confidence level) with the activation of the geometric refinement using the GRI.

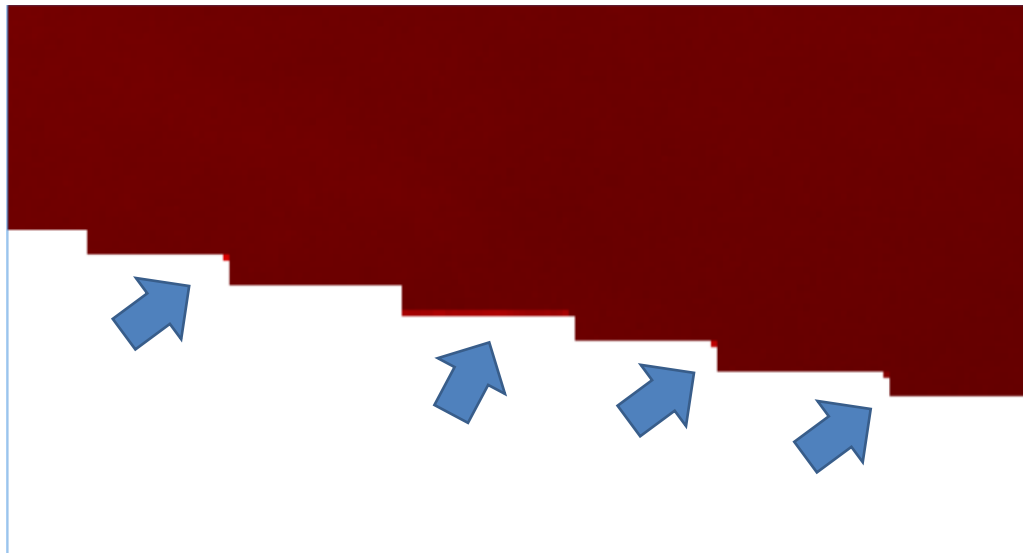
This anomaly is characterized by anomalous pixel values at the boundary of a datastrip. This anomaly has been corrected with baseline 02.02.

Figure 10: Anomalous pixels on band B4 (anomaly #12).

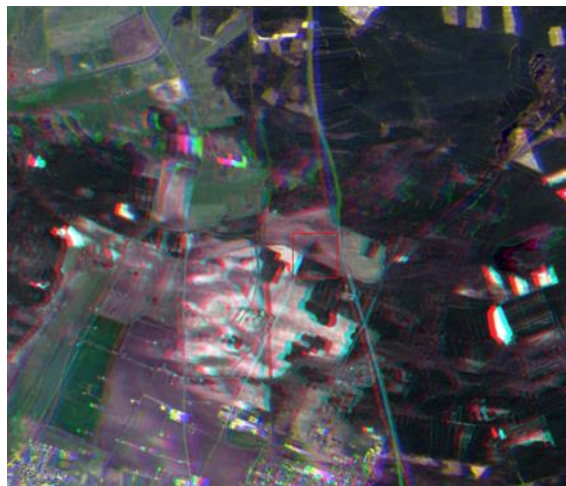
A major anomaly has led to a strong and temporary geolocation and spectral registration errors. The anomaly occurred on February 3rd (orbit 3218) and April 3rd (orbits 4080, 4081 and 4082). This anomaly has been correctly identified by the automatic on-line quality control and the degraded geometric performance is reported in the product metadata (geometric quality check status is "FAILED"). After identification of the anomaly, the defective products have been removed from the public archive.

The root cause of this anomaly has been identified. Missing data from attitude control telemetry is at the origin of the anomaly. An optimization of the management of the on-board telemetry has been implemented since and should avoid any re-occurrence.

Figure 12: Spectral co-registration error (anomaly #14).

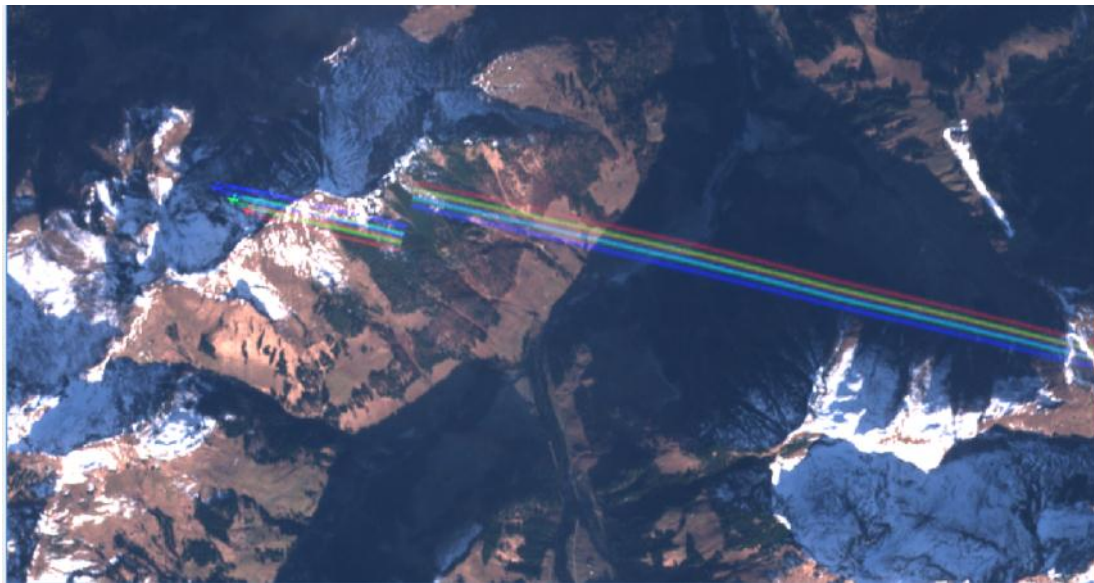
The processing algorithm ensures the coregistration of images acquired by all spectral bands and the detectors for features at ground level. Objects at a higher altitude like planes and clouds cannot be properly coregistered. As already reported in the first issue of the Data Quality Report, this effect leads to spectral misregistration ("rainbow" effect) and discontinuities between detectors.

Both effects can be seen in Figure 19 below.

Figure 19: Spectral misregistration and detector misalignment for object at high altitude (plane and contrail). This feature is not an anomaly.
